**HOWARD COUNTY HISTORIC PRESERVATION COMMISSION**

ELlicott City Historic District ■ LAWYERS HILL Historic District

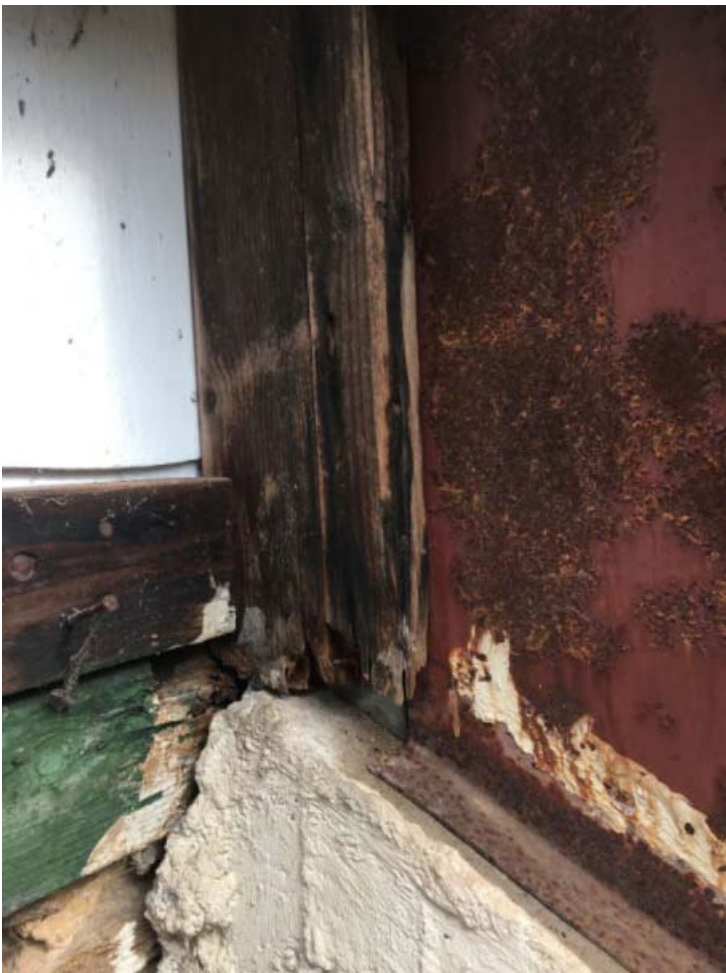
Large crack, exterior of Bilco doors

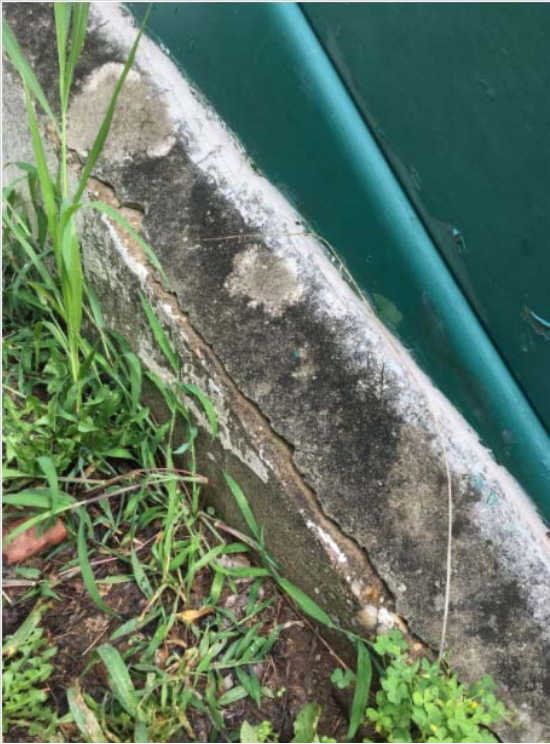
Newer wall, evidence of water

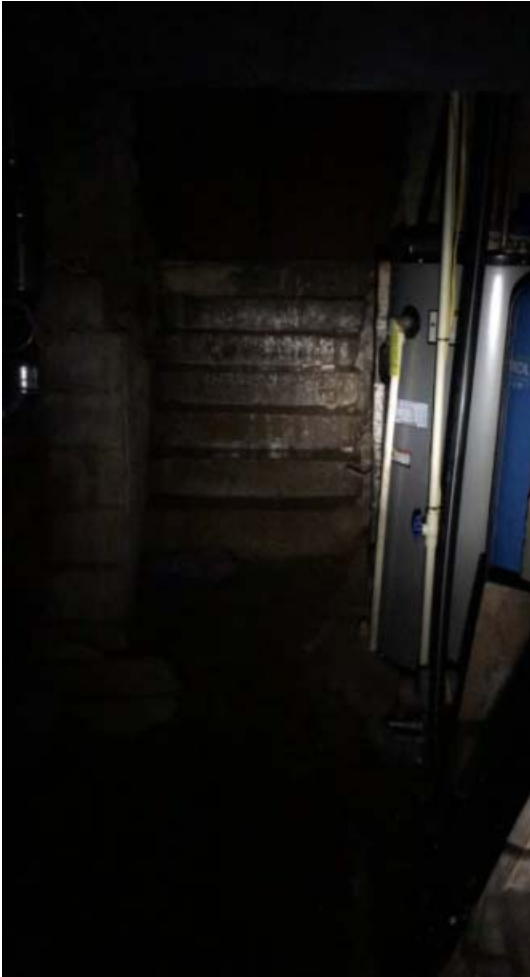
# Repair holes in foundation walls

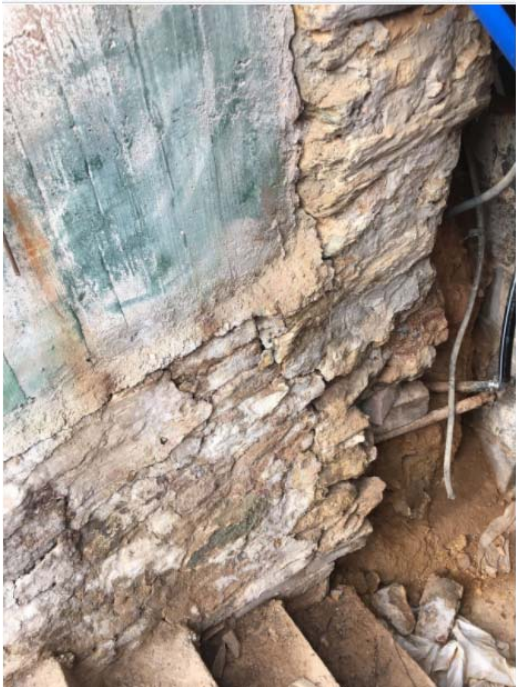
Foundation wall left wall near exit

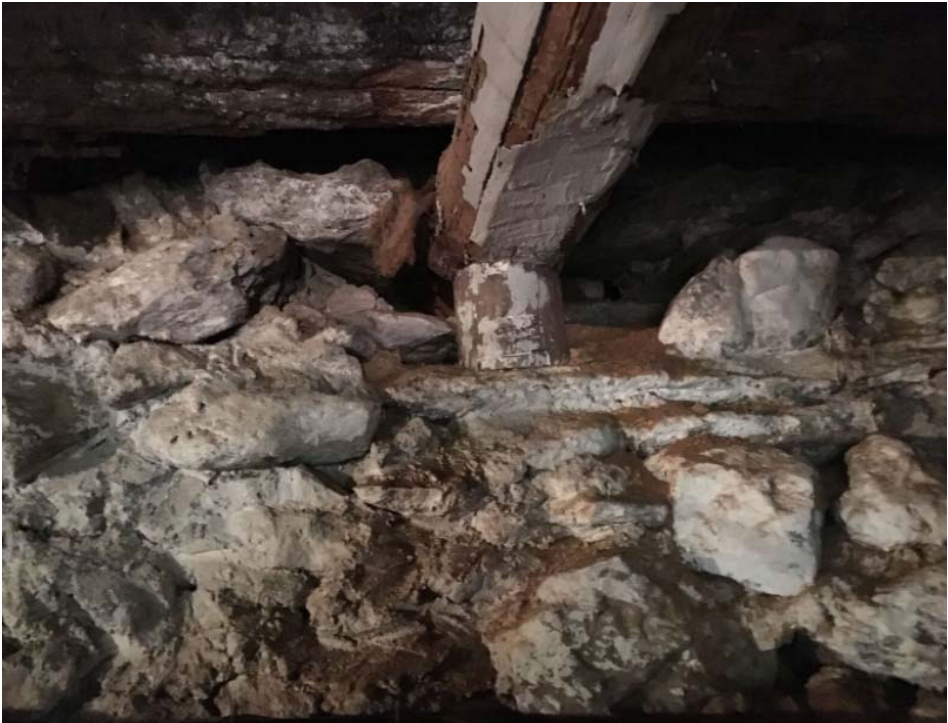
Foundation wall, masonry degraded

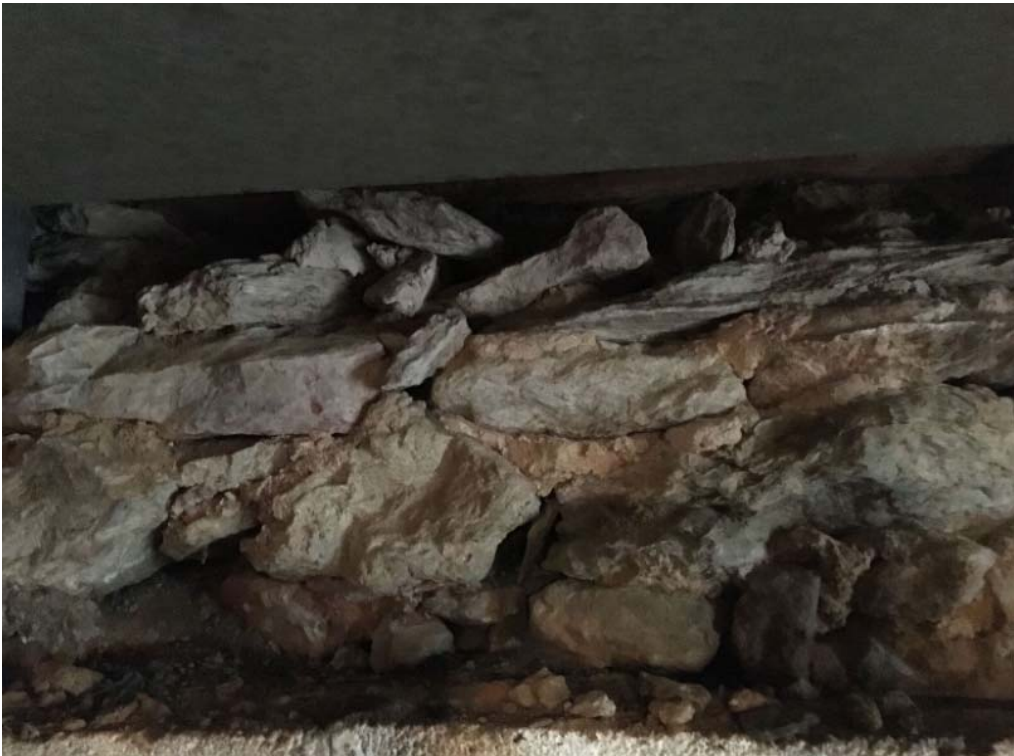
Foundation wall near exit

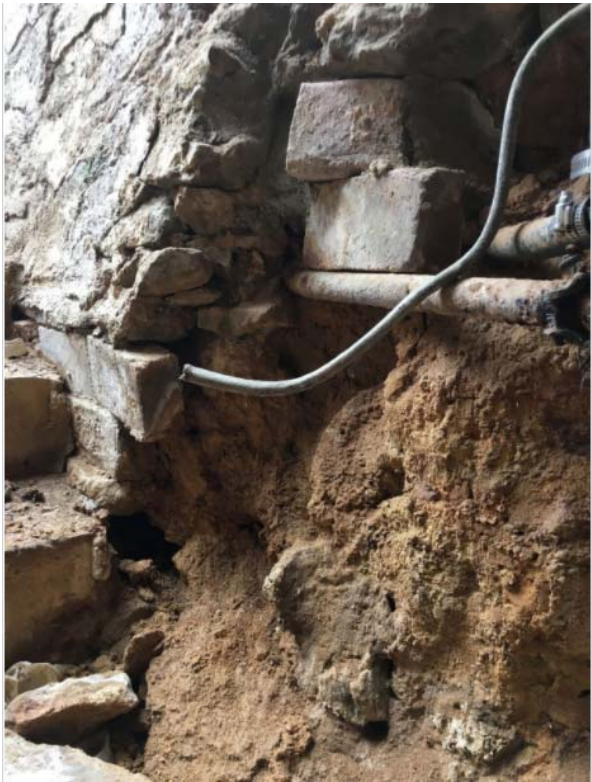
# Reinforce damaged floor joists

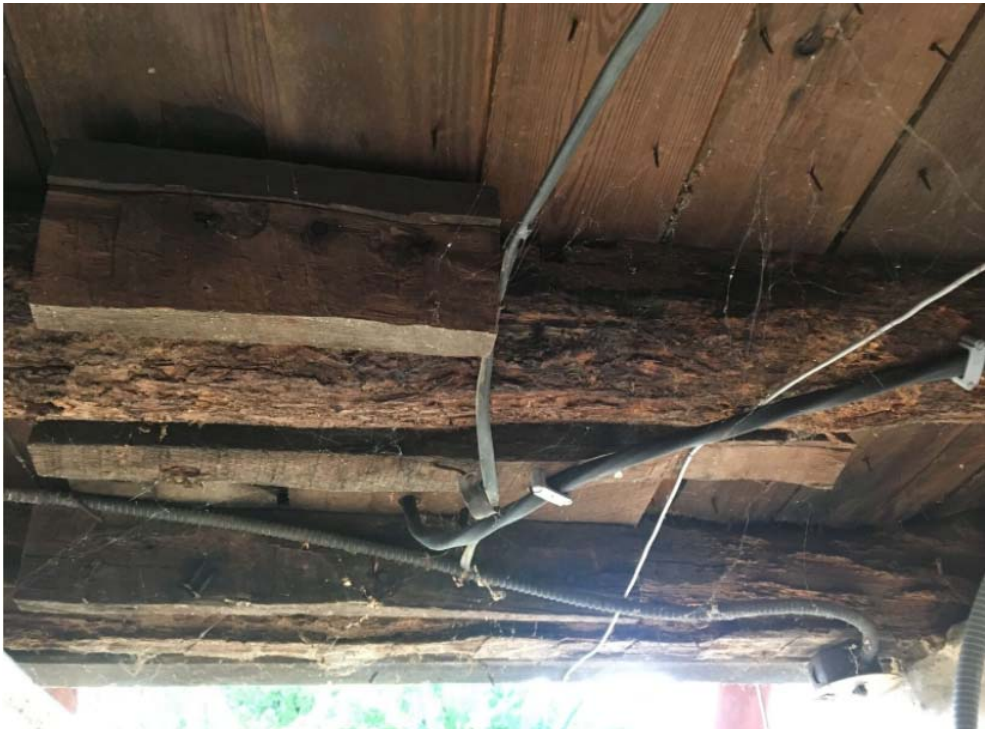
Bug damaged joist near exit

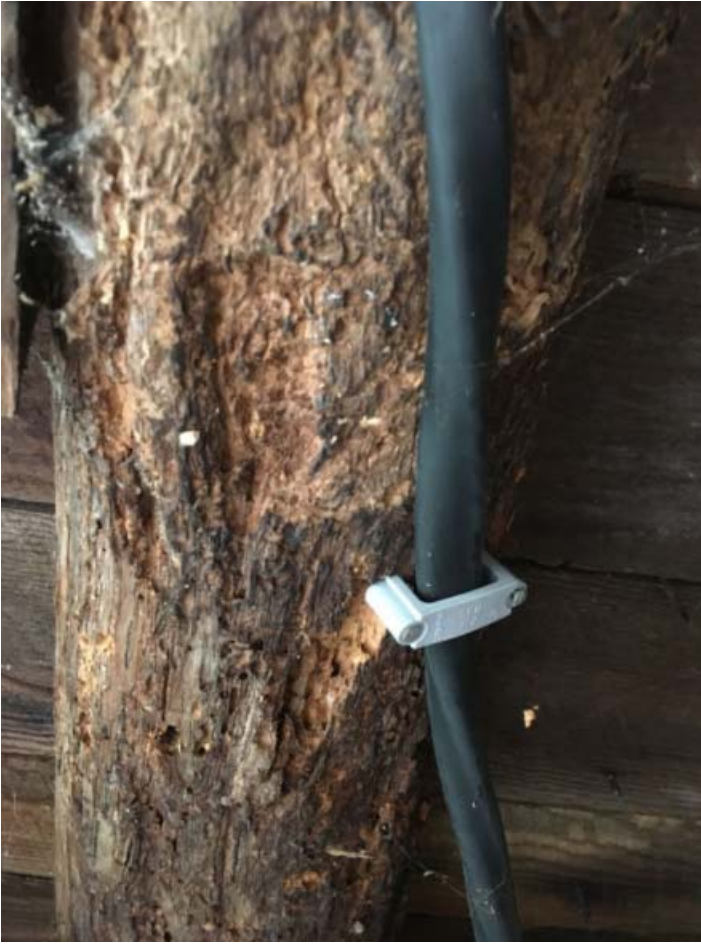
Damaged joist (main house joist)

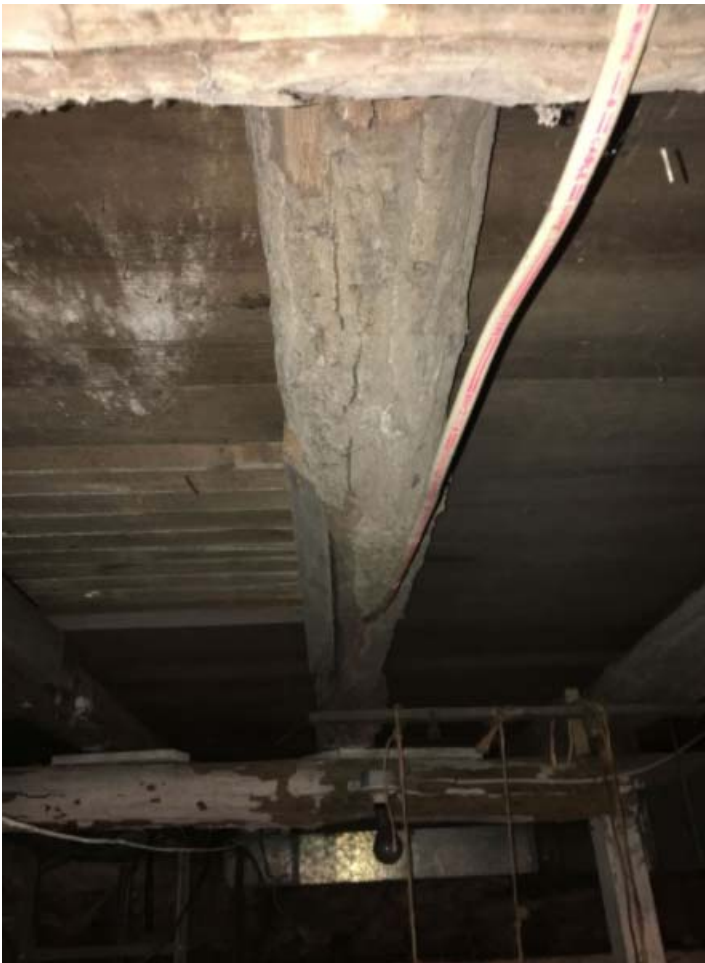
## Replace existing wood and metal support columns, place on concrete footings

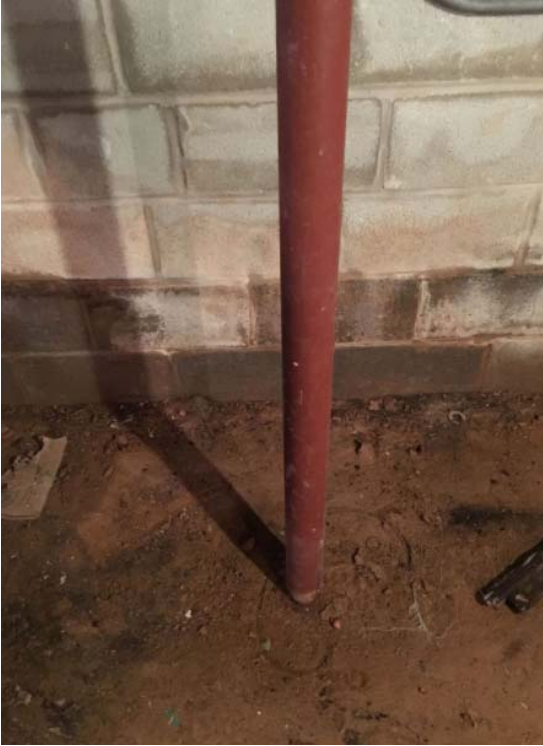
Existing metal column, set on dirt (corroded bottom)

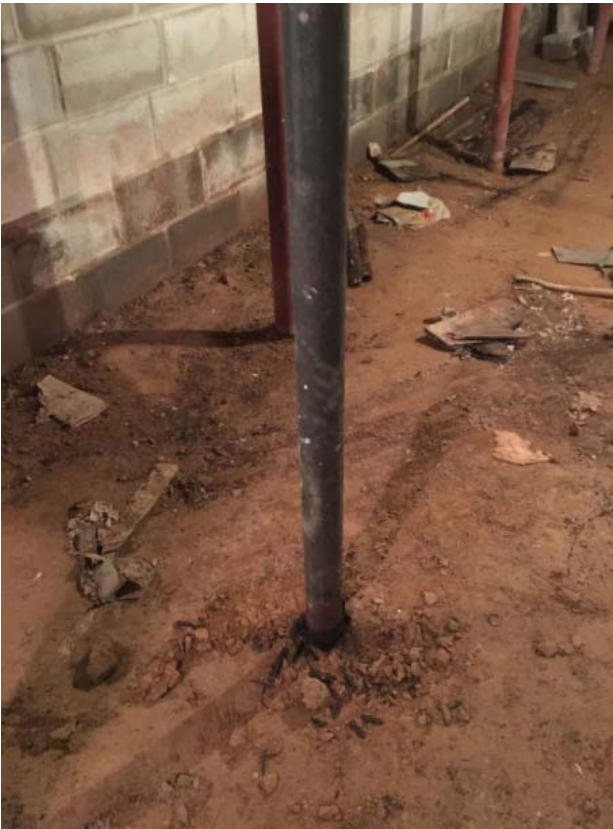
Existing wood column, currently set on concrete remnant

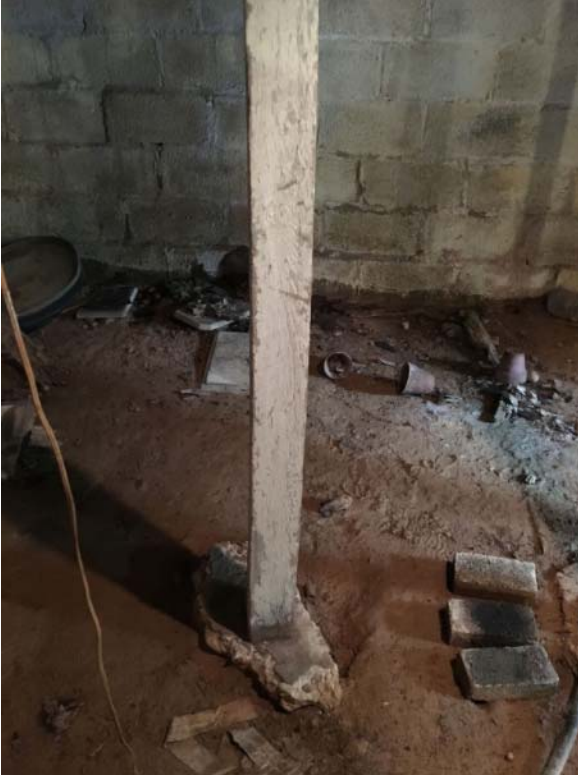
2. Potential need for external repointing of mortar.

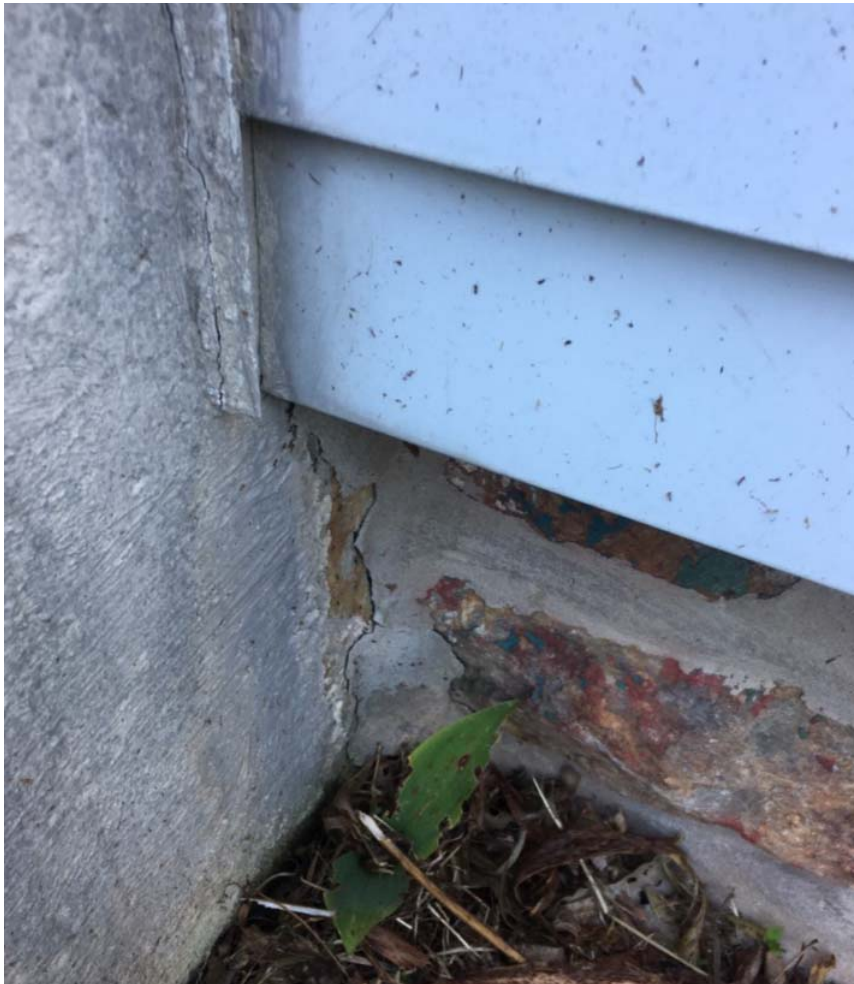
Cracks and holes in exterior foundation, may need repointing.

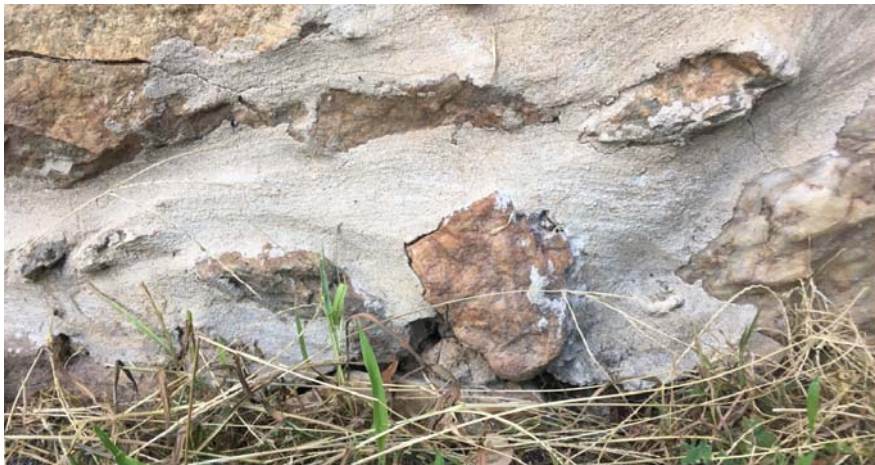
Gaps and holes in exterior foundation, may need repointing.

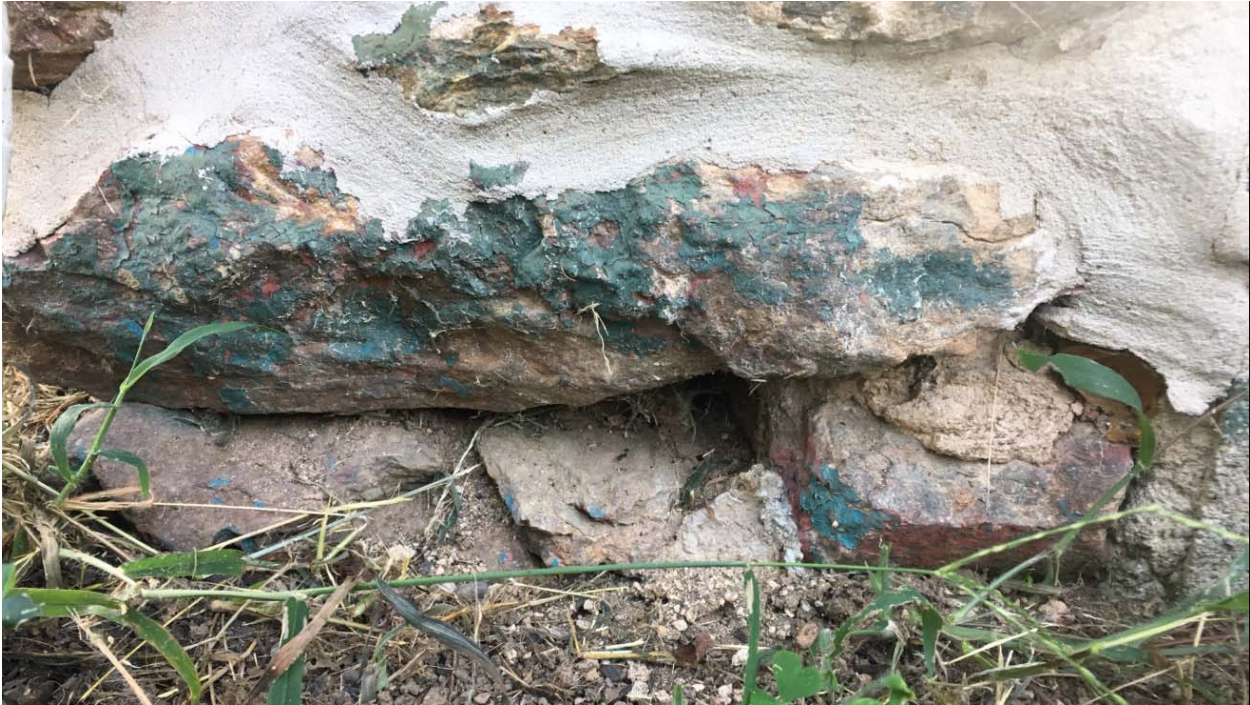
4. Fill cellar wall with concrete.

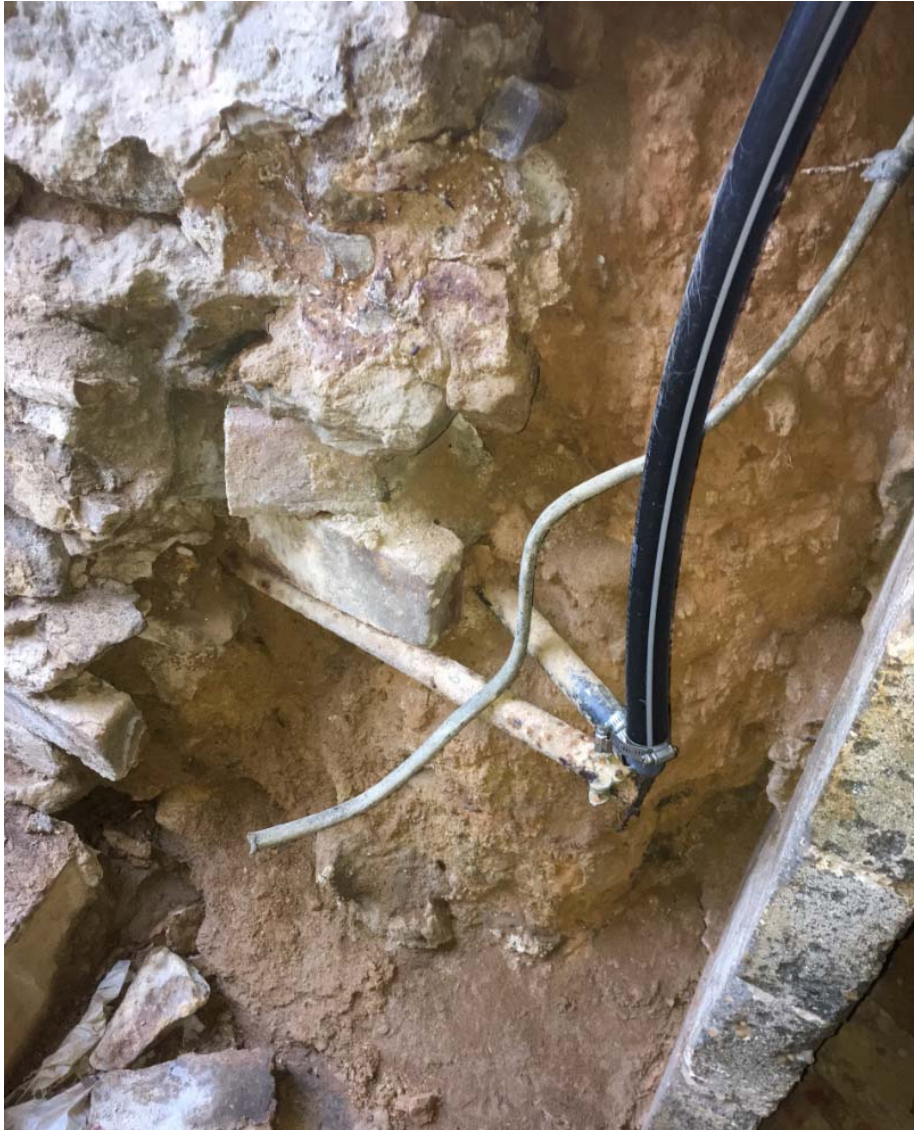
This is near the cellar entrance. Note the dirt on the right side of the picture and significant erosion. Also note loose bricks falling out of the foundation (2 are laying on the ground)

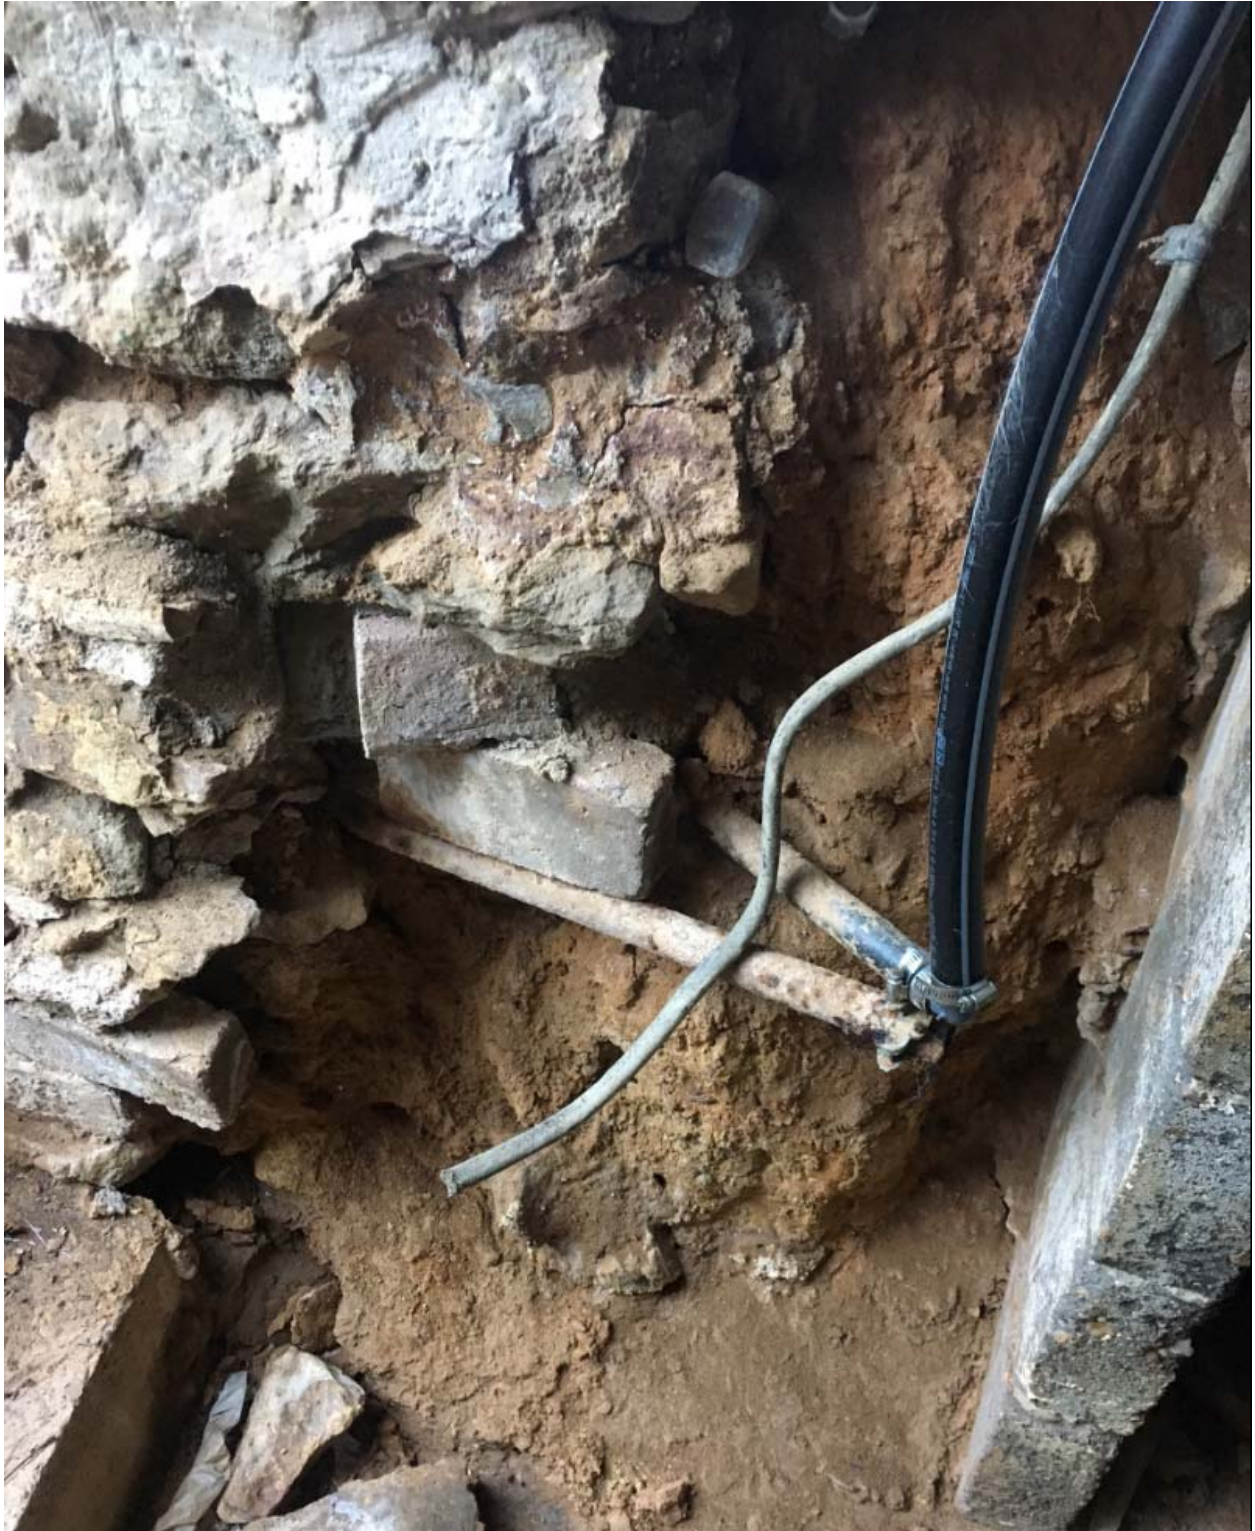
Closer view of crumbling foundation wall by entry way. Note bulging, loose bricks and stones. Also note holes where water comes in.

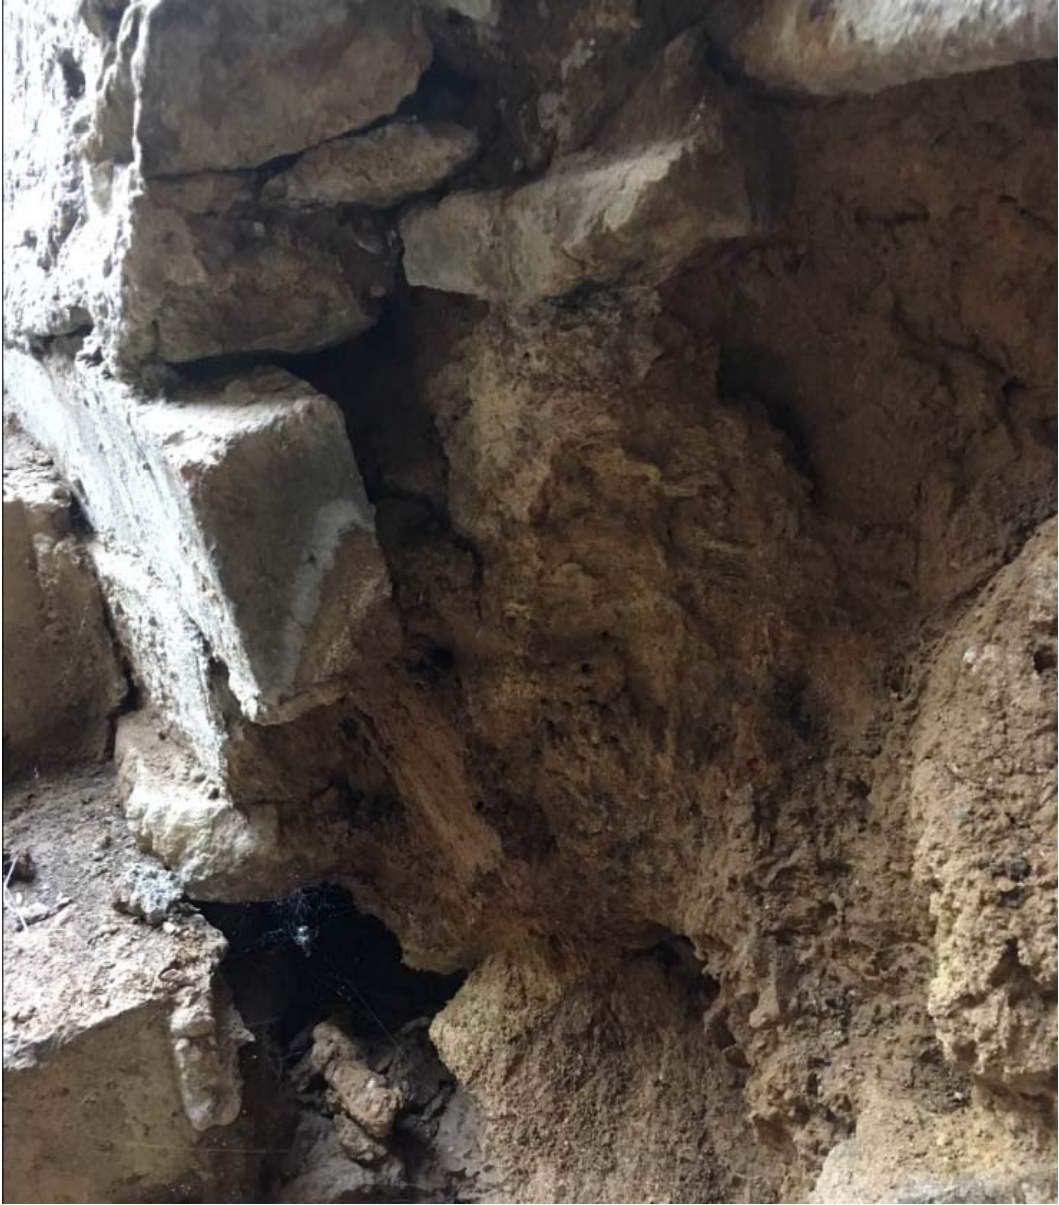
5. Cellar door- evidence that door is no longer water tight (this is the side where the frame rests on the concrete entryway).

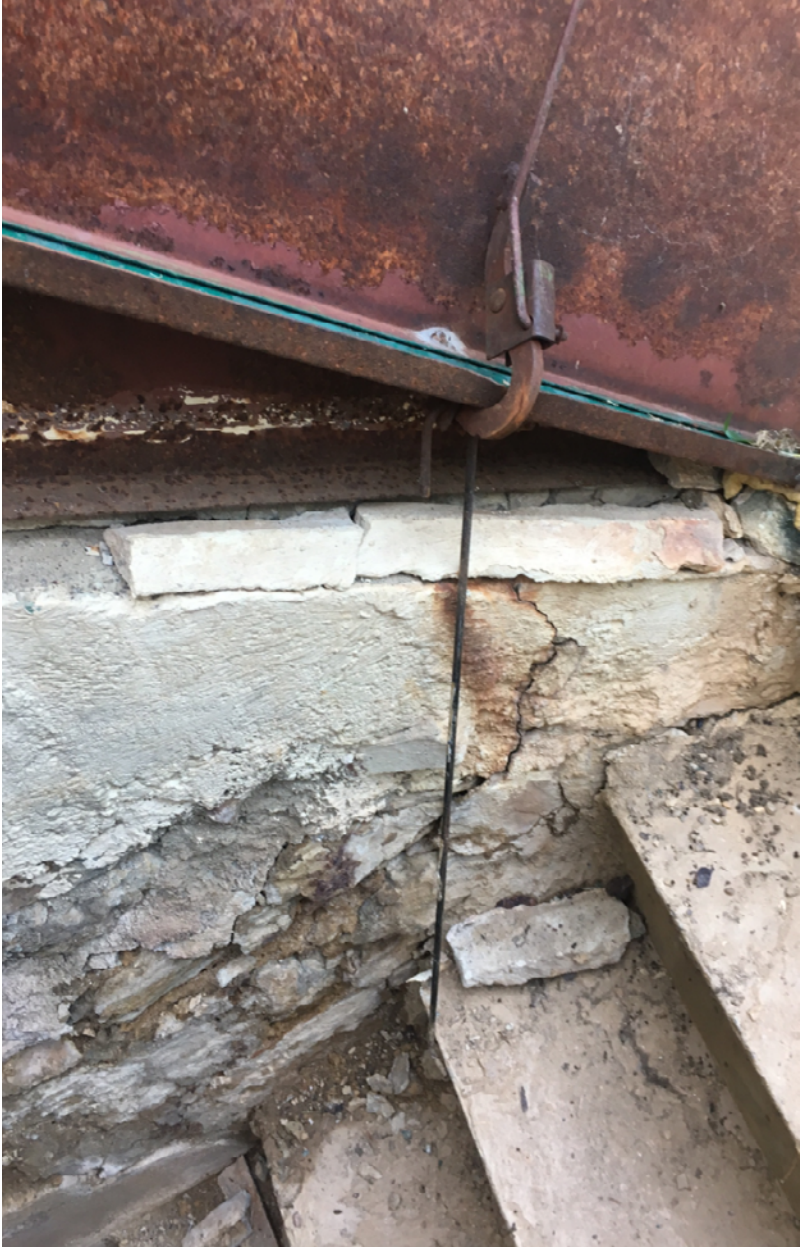
Outside of cellar door. Note large crack along frame. No longer connects to cement foundation.

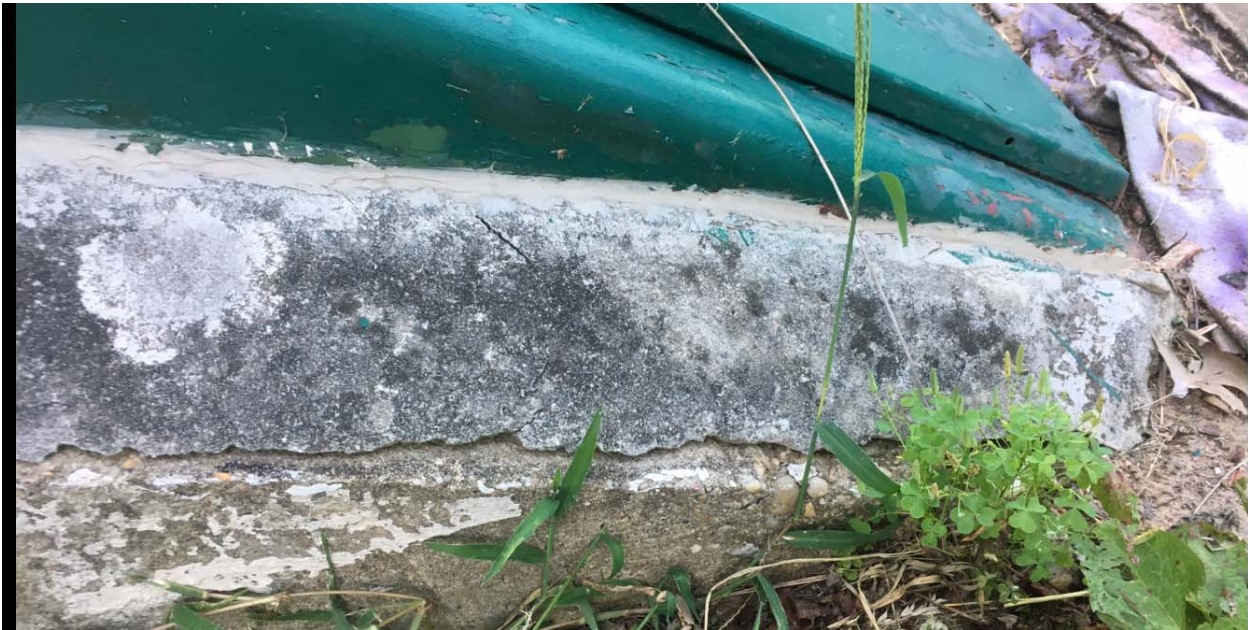
Other side of external view of cellar door. Note cracks in both caulking and mortar.

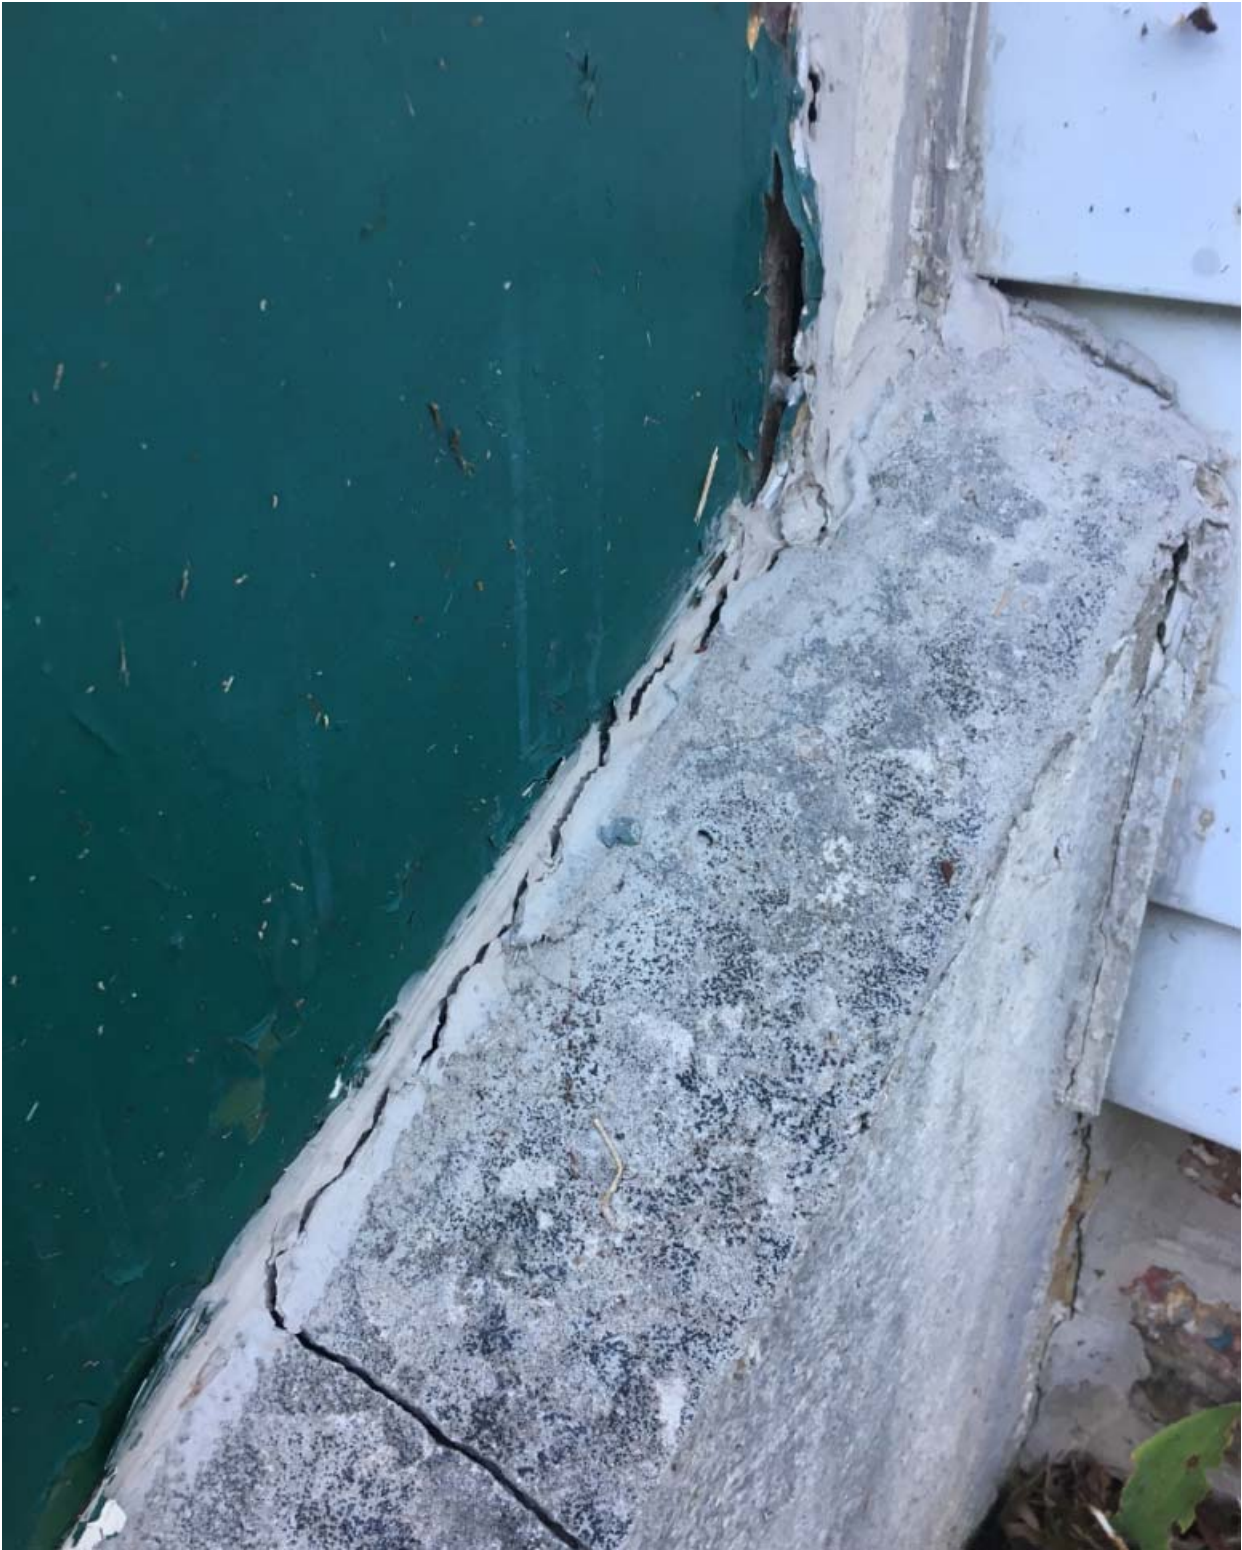
Close up view of cement foundation for cellar door. Note large crack.

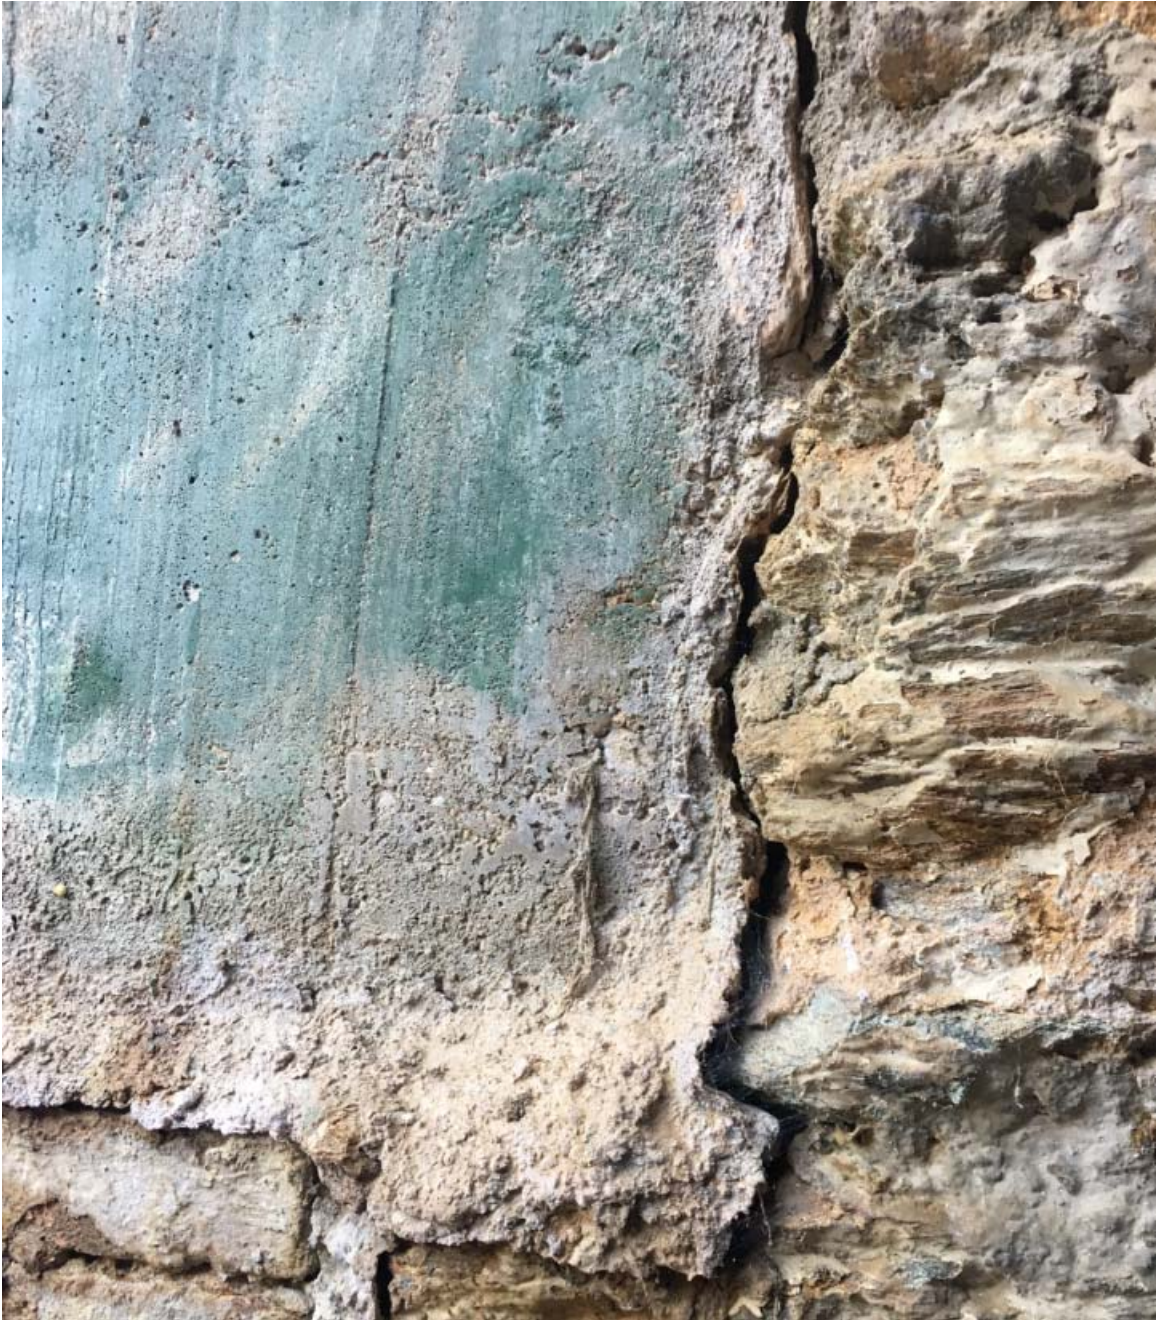
External view of cellar door- cracks in foundation

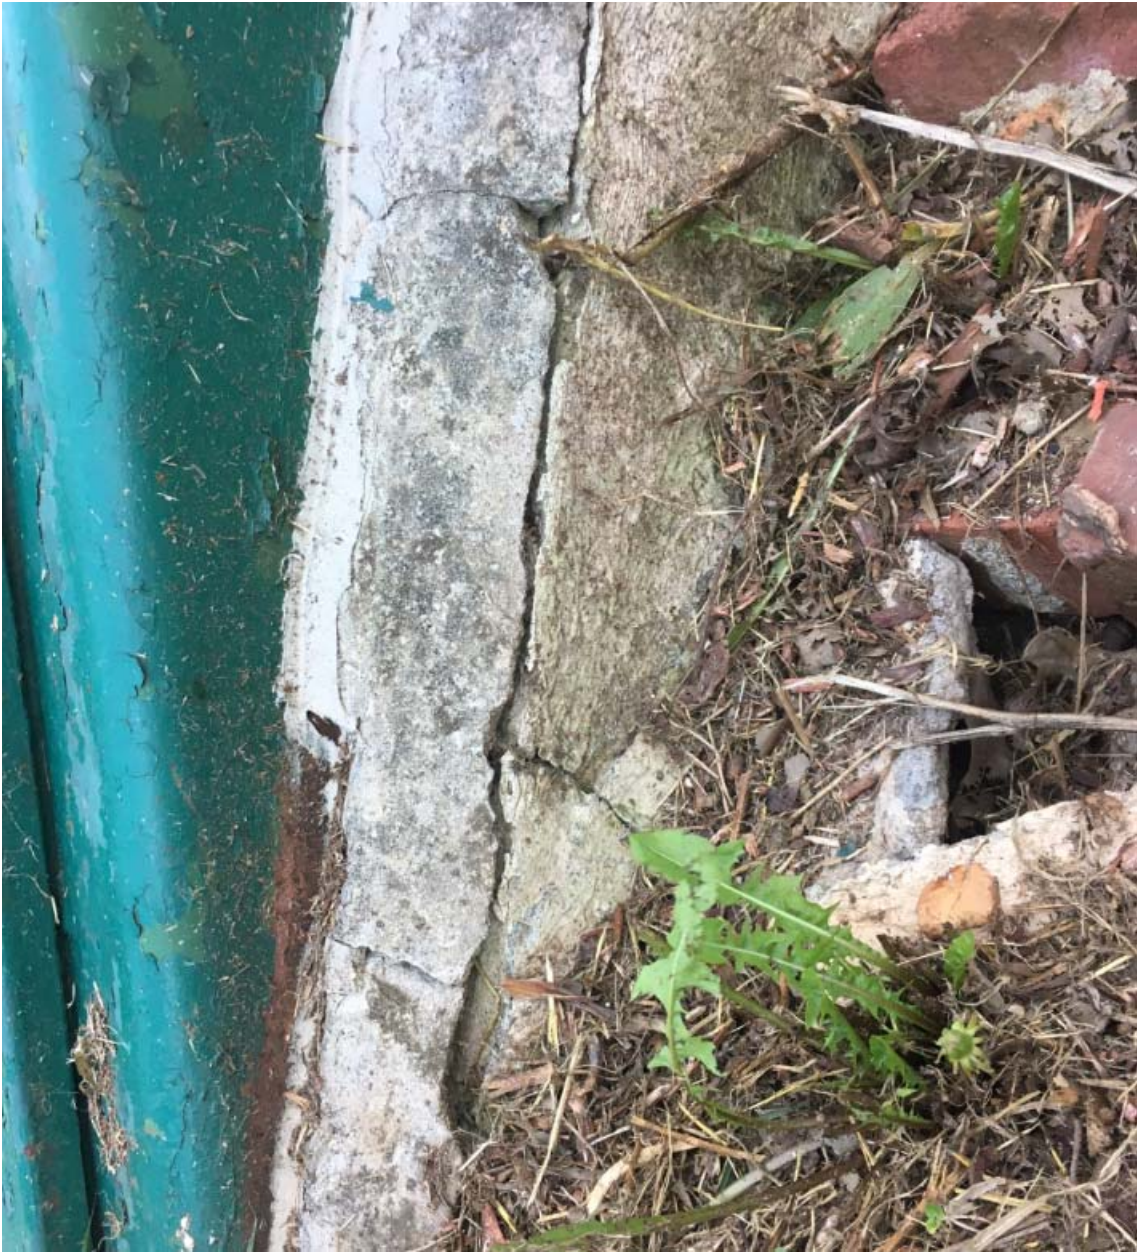
# **PROPOSAL FOR WORK**
