## WATER HEATER DIP TUBES – WHY ALL THE FUSS?

### **by Danny T. Hutchins, PhD**

In 1995, the Charter Township of Clinton (Mich.) Water and Sewer Department investigated complaints at an apartment building for seniors. In two apartments, tenants had found small, white or light green-tinted particles in their aerators and

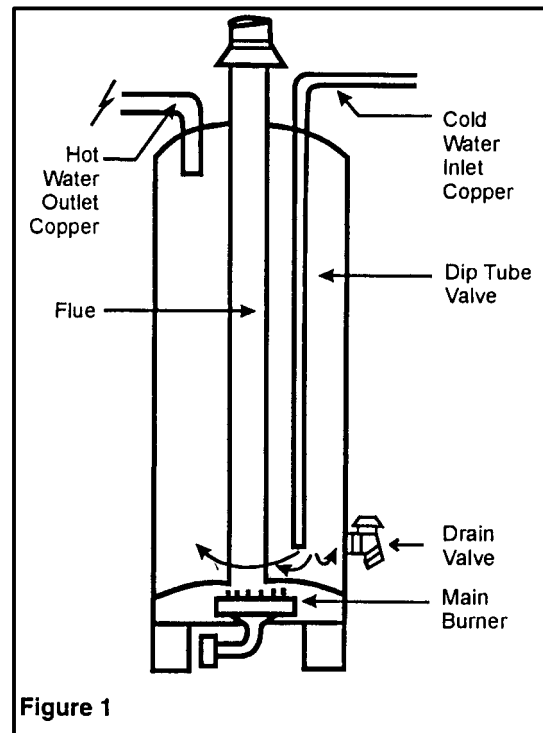
extending nearly to the bottom of the tank. *Figure 1* shows a normal dip tube as it extends from the copper cold-water inlet pipe down into the tank. The dip tube directs cold water to the bottom of the heater to be heated, allowing hot water to rise to the top of the tank. By directing cold water to the bottom of the tank, the incoming cold water pushes the heated water out in front of it. This allows the hot water to be used without diluting the temperature of the hot water that occupies three-fourths of the tank.

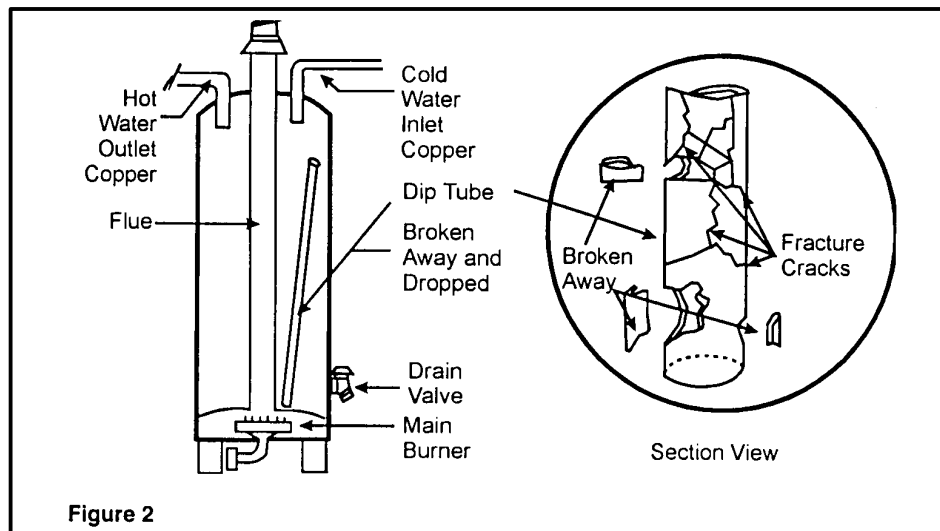
*Figure 2* shows that heat has softened the plastic dip tube, and turbulence created inside the water heater has caused the dip tube to break off. With the dip tube broken away, the cold water comes into the top of the tank, creating more turbulence while reducing temperatures and requiring the thermostat to be adjusted upward. The hot water continues to change the structure of the nonmetallic dip tube, causing it to become brittle.

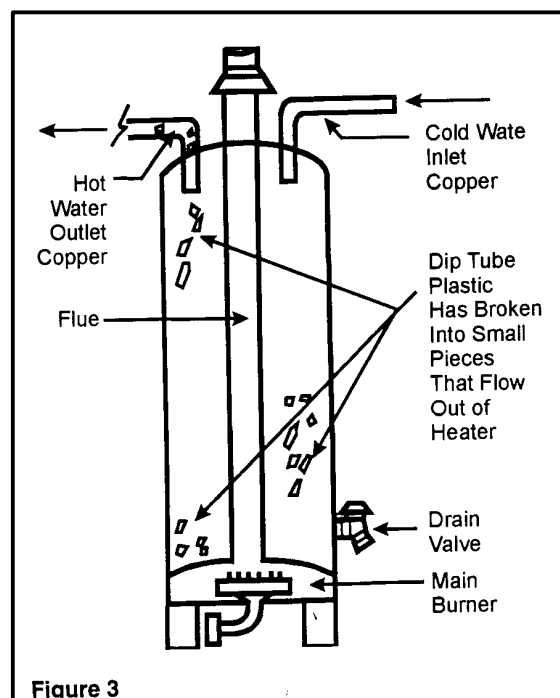
**Figure 3** shows that over time, the dip tube continues to change. Cracks and fractures form all over the dip tube surface. The turbulence created inside the tank breaks the tube into increasingly smaller pieces. The pieces are eventually flushed out of the tank through the hot water outlet. The missing dip tube also reduces the supply of hot water.

**1. Flush the debris from the heater tank, install a new dip tube, and flush the strainers and aerators.** In order to flush the heater tank, a full-port drain valve has to be installed for each heater. In the case of the apartment complex, the approximate cost to flush the heater and replace the dip tube was \$280 to \$300 per unit. It took 45 minutes to an hour to clean all the strainers, aerators, and fixtures in one apartment.

**2. Replace the water heater and clean and flush the strainers and aerators.** The cost of this method was projected at \$450 to \$500.
