# Northern Little Patuxent River Watershed Assessment

COMMUNITY MEETING NO. 1  
June 22, 2015

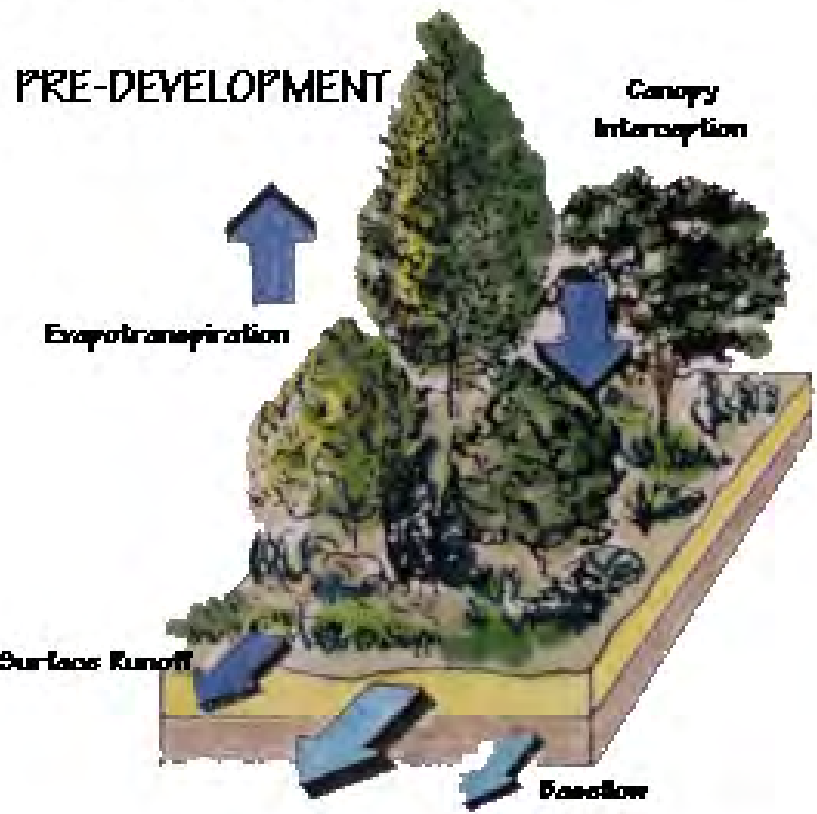
## PRE-DEVELOPMENT

# WATER BALANCE

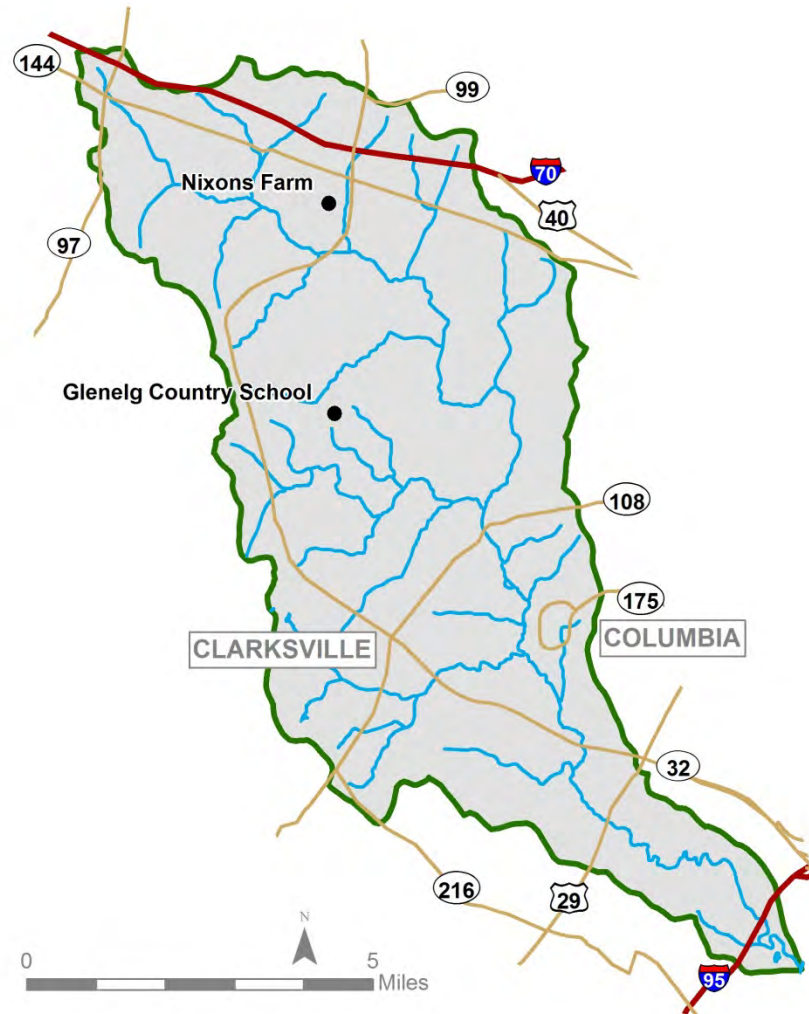
# Middle Patuxent River Watershed

- 58 square miles
- 37,074 acres
- 3,675 impervious acres
- 12,367 wooded acres
- 227 miles of streams
- 593 stormwater BMPs treating 40 of impervious

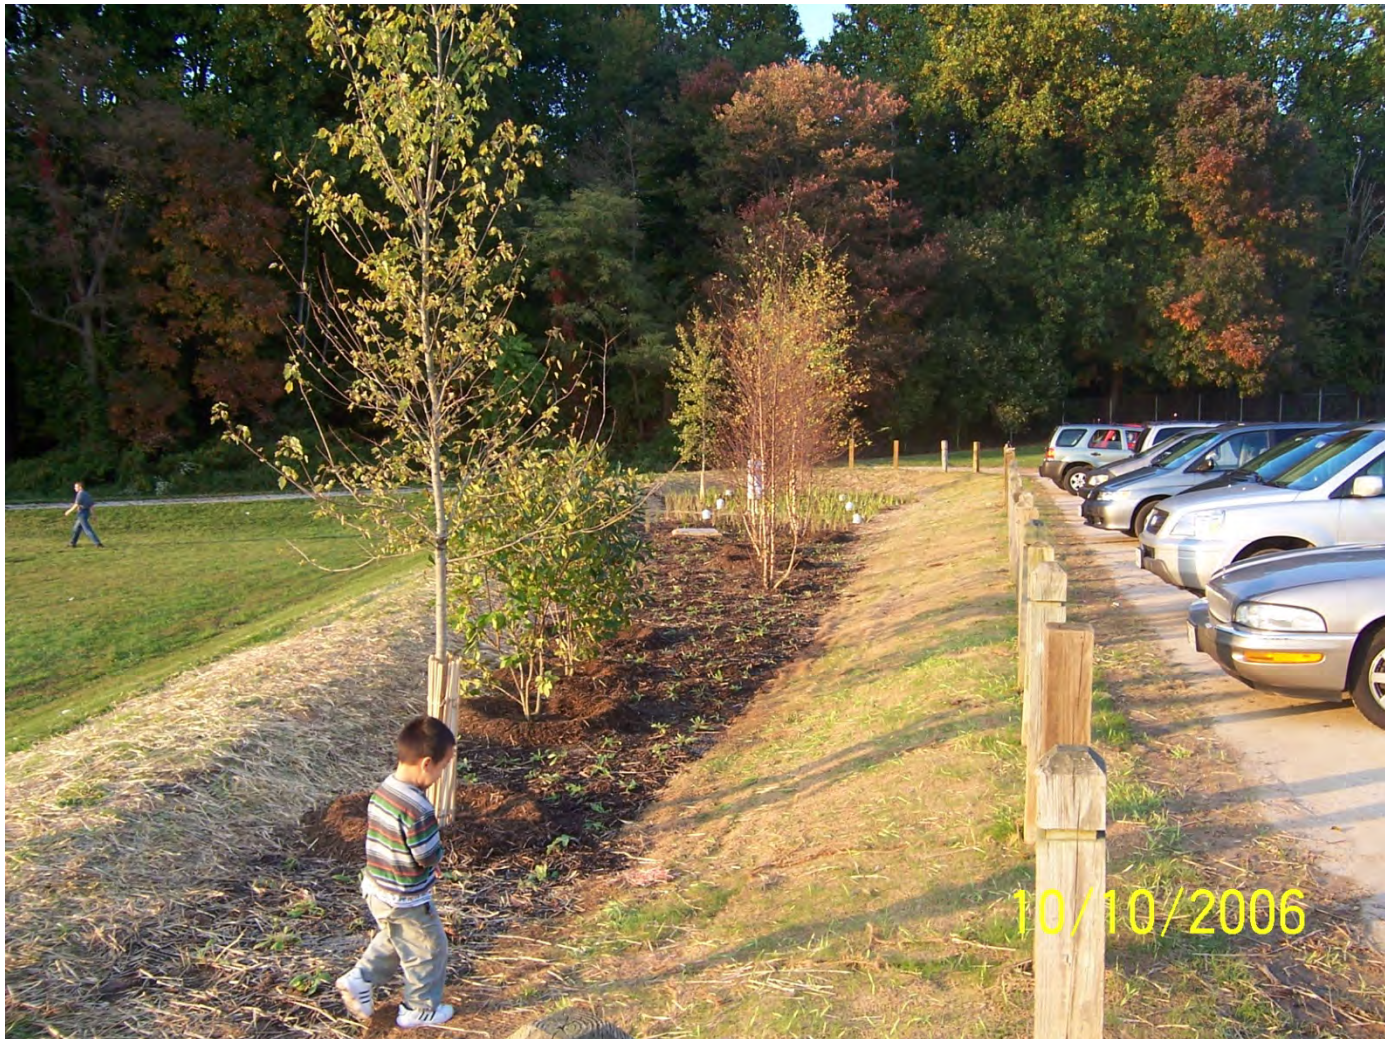
# Bioretention Facility

## BIORETENTION FILTER
