Biological Assessment of the Rocky Gorge, Hammond Branch, and Dorsey Run Watersheds, Howard County, Maryland

Spring 2003 Index Period

January 2004

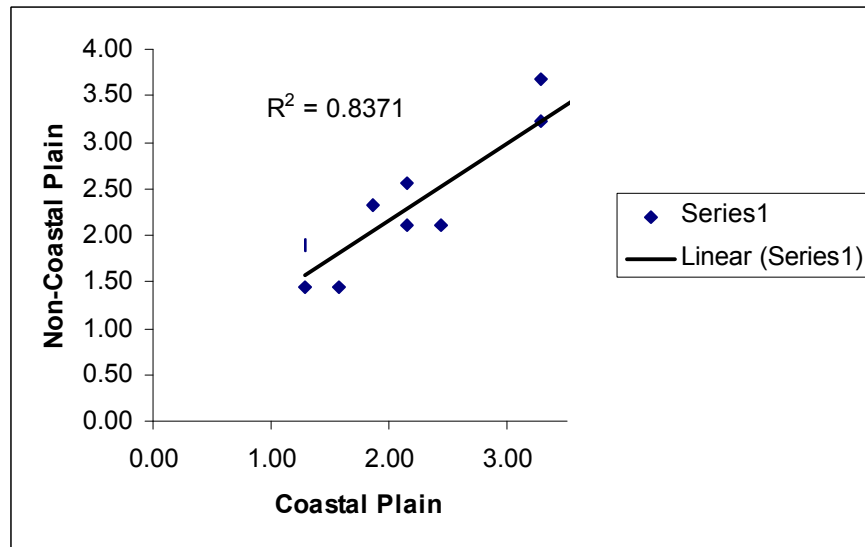
Ten of the 20 probability sites sampled in Rocky Gorge and Dorsey Run are located in the transitional zone between Non-Coastal Plain (NCP) and Coastal Plain (CP) ecoregions (all of Hammond Branch is located in the Non-Coastal Plain). A correlation analysis was performed on the final biological index scores of the 10 transitional zone sites. A comparison of the final index scores revealed that there was not a significant difference in rating, $r = 0.84$. Figure 4 graphically shows the relationship. Since no significant difference was found, all of the sites from Rocky Gorge, Dorsey Run, and Hammond Branch were scored using the NCP metrics. These will be able to be compared to past and future assessments across the County.

Figure 4. Correlation of NCP and CP final index scores for 10 sites in the transitional zone of Howard County.

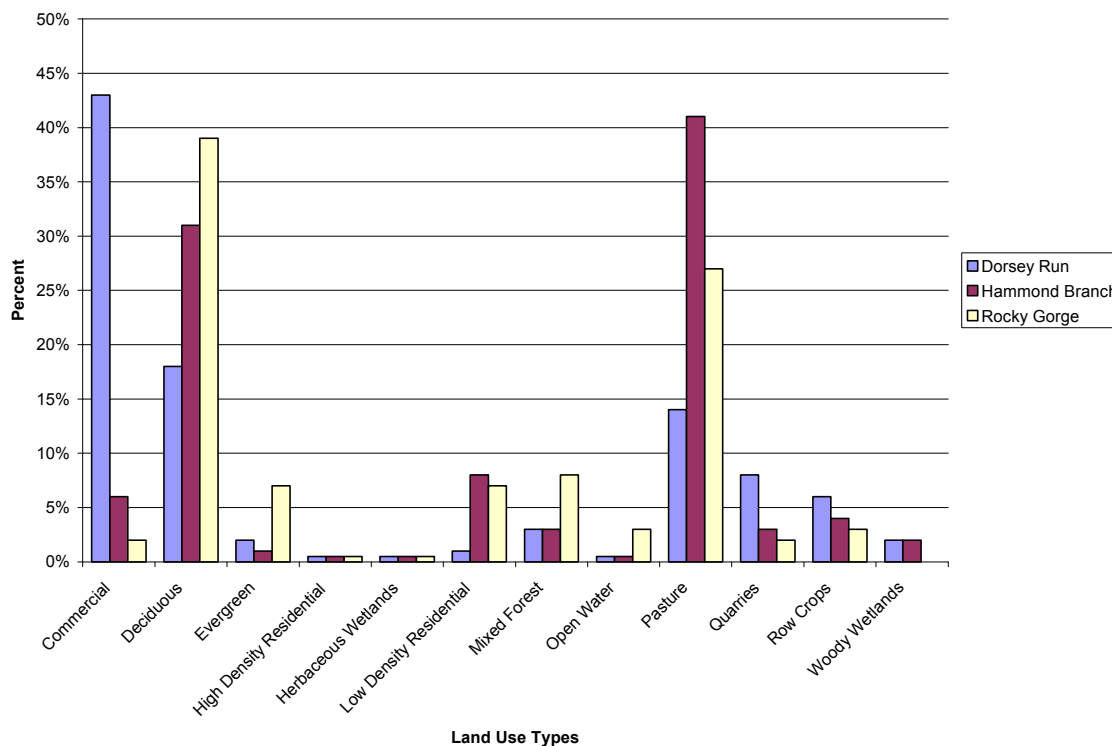
Land use percentages were calculated for each subwatershed sampled this year (Figure 5). Rocky Gorge and Hammond Branch, both in the southwestern part of the County, are dominated by pasture and deciduous forest. Dorsey Run (in the southeastern section of the County) however, has more commercial land use. This could be due to I-95 and it’s various interchanges running through that section of the County.

Figure 5. Percent land use type in the Dorsey Run, Hammond Branch, and Rocky Gorge subwatersheds.

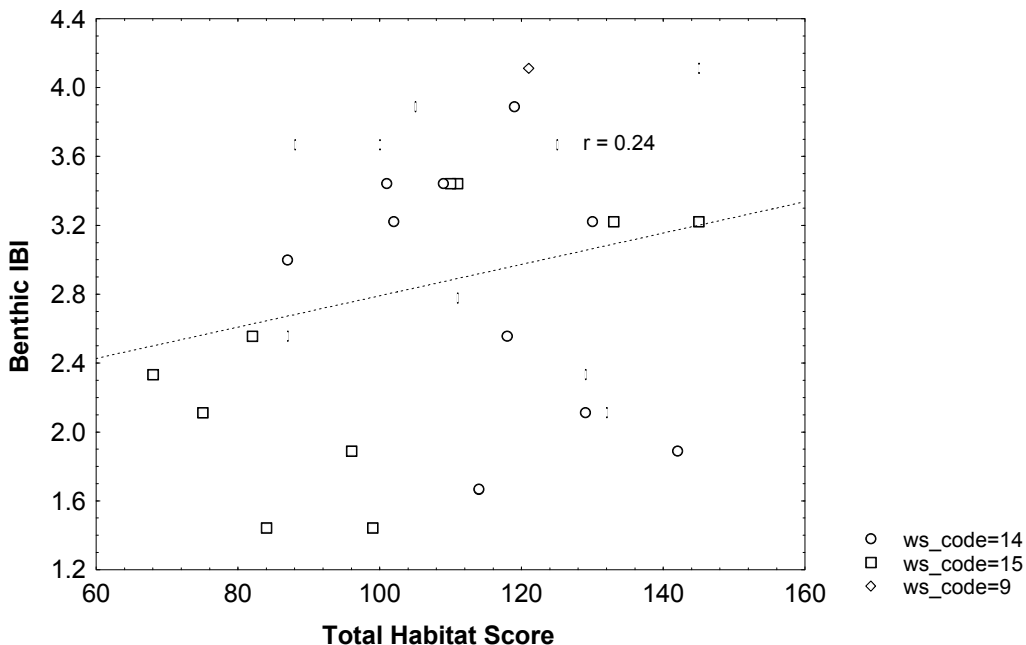
Biological integrity was compared to physical habitat condition for the subwatersheds sampled in the 2003 sampling period (Figure 6). The lack of positive correlation between biology and habitat could be attributed to effects of excess nutrients (Rocky Gorge) or chemical runoff (Dorsey Run and Hammond Branch) that were not measured in this study. Figure 7 shows overall biological condition for the Dorsey Run, Hammond Branch, and Rocky Gorge subwatersheds.

Figure 6. Scatterplot of the biological and physical habitat scores among the Dorsey Run, Hammond Branch, and Rocky Gorge subwatersheds.

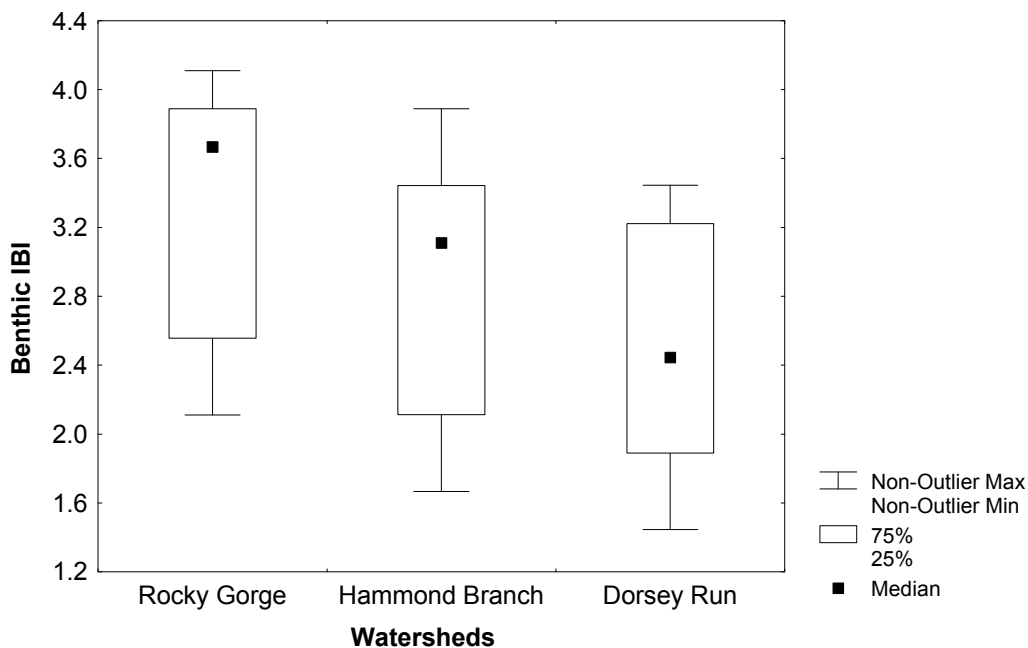
Figure 7. Biological scores in the Rocky Gorge, Hammond Branch, and Dorsey Run subwatersheds.

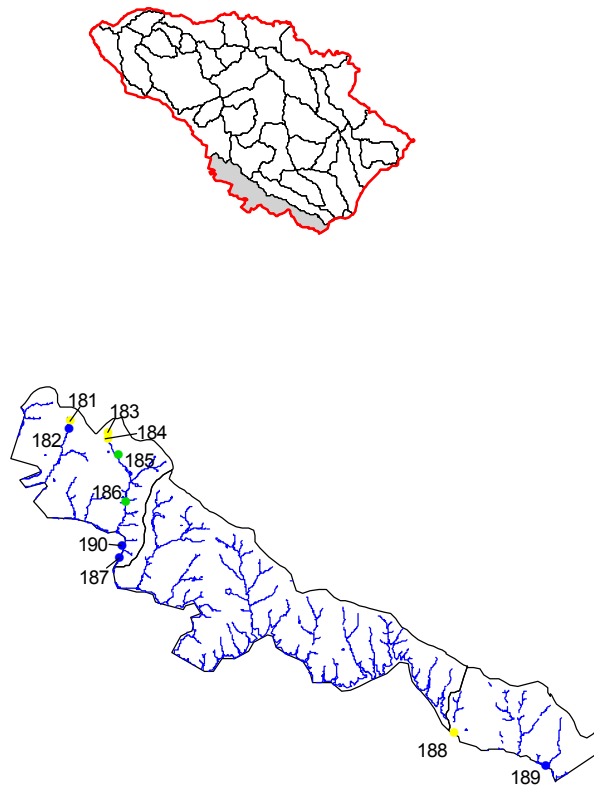
The mean biological condition for this subwatershed is “fair” ($\bar{x} = 3.29 \pm 0.80$, $n = 10$). Two sites rated “good”, four sites rated “fair”, and four sites rated in “poor” biological condition (Table 7, Figure 8). The mean physical habitat rating for this subwatershed is “non-supporting” (57% of maximum; Table 7). Of the ten sites sampled, 50% were “partially supporting” and the other 50% were rated as “non-supporting”. Correlation between physical habitat quality and biological condition had a very low r -value ($r = 0.12$; Pearson product moment), suggesting that stressors other than habitat are having a substantial effect on overall biological condition in this subwatershed.

Figure 8. Color-coded biological ratings for the Rocky Gorge subwatershed. Green = good, blue = fair, yellow = poor, red = very poor. 181-190 indicate site numbers.

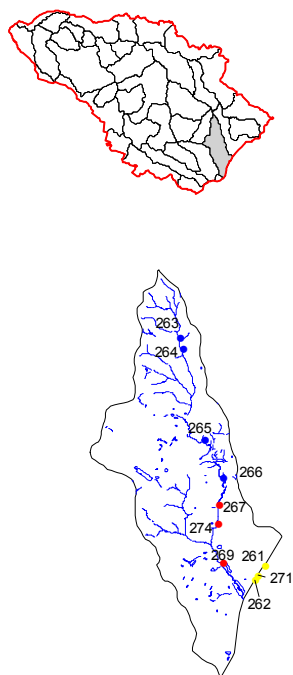
The mean biological condition in this subwatershed is “poor” ($\bar{x} = 2.51 \pm 0.74$, $n = 10$). Four sites were rated as “fair,” three as “poor,” and the last three as “very poor” (Table 8, Figure 9). Mean physical habitat is “non-supporting” ($\bar{x} = 110.3 \pm 24.90$, $n = 10$) of a healthy biological community. Only two sites were rated as “partially supporting,” while the remaining eight sites were “non-supporting” (Table 8). Pearson product-moment showed that biological condition is somewhat correlated with physical habitat condition ($r = 0.63$).

Figure 9. Color-coded biological condition ratings for the Dorsey Run subwatershed. Green = good, blue = fair, yellow = poor, red = very poor. 261 –274 indicate site numbers.

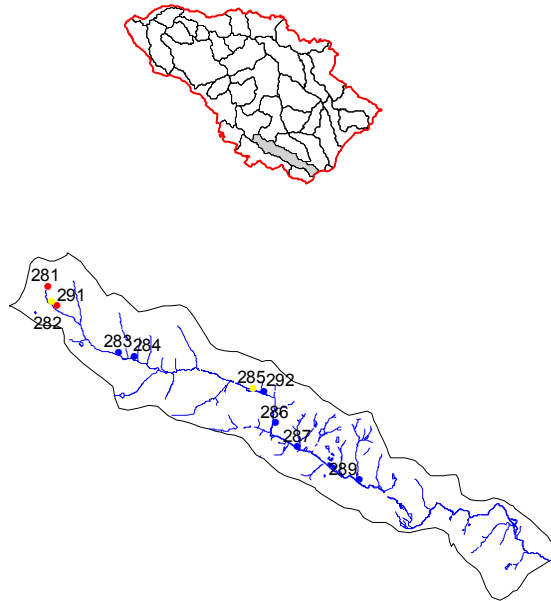
Figure 10. Color-coded biological condition ratings for the Hammond Branch subwatershed. Green = good, blue = fair, yellow = poor, red = very poor.
