# Case Study: Ellicott City Flood Event

Case Study-2016 Ellicott City Flood Event

Smith Planning and Design, LLC

3/15/2017

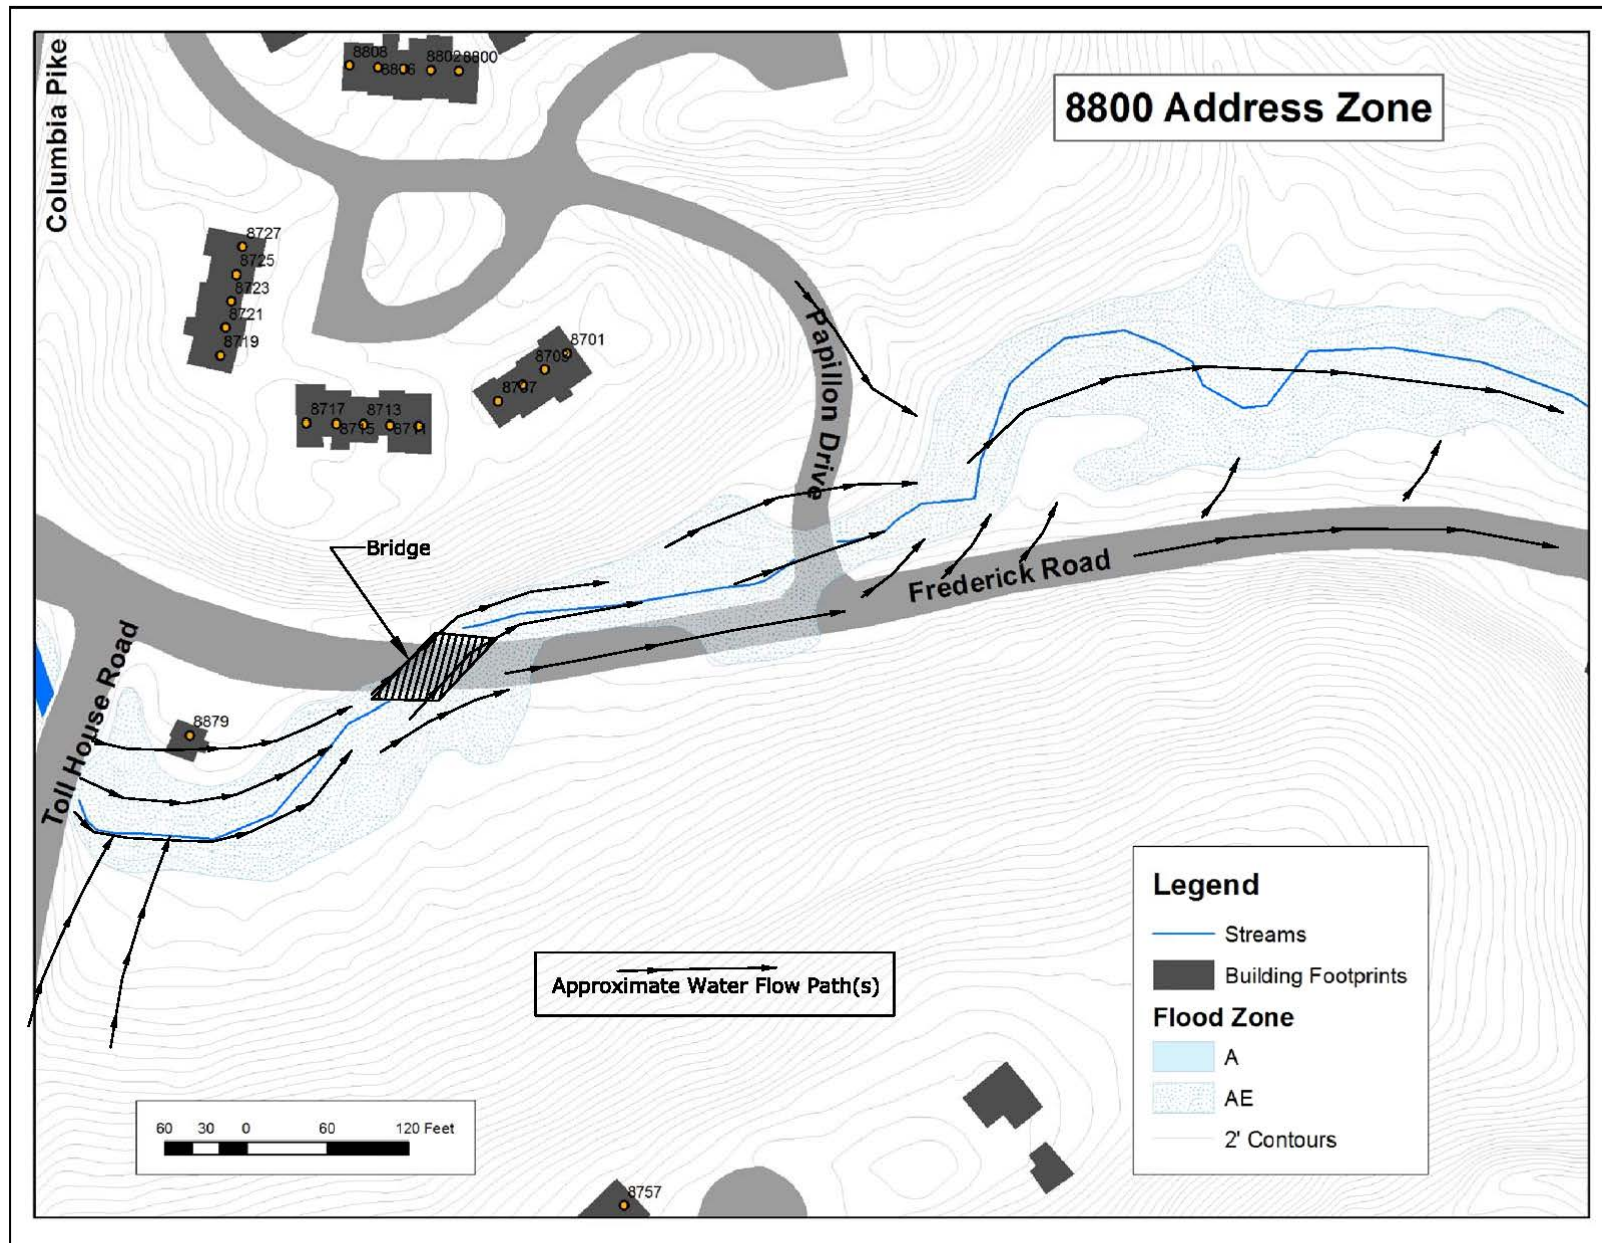
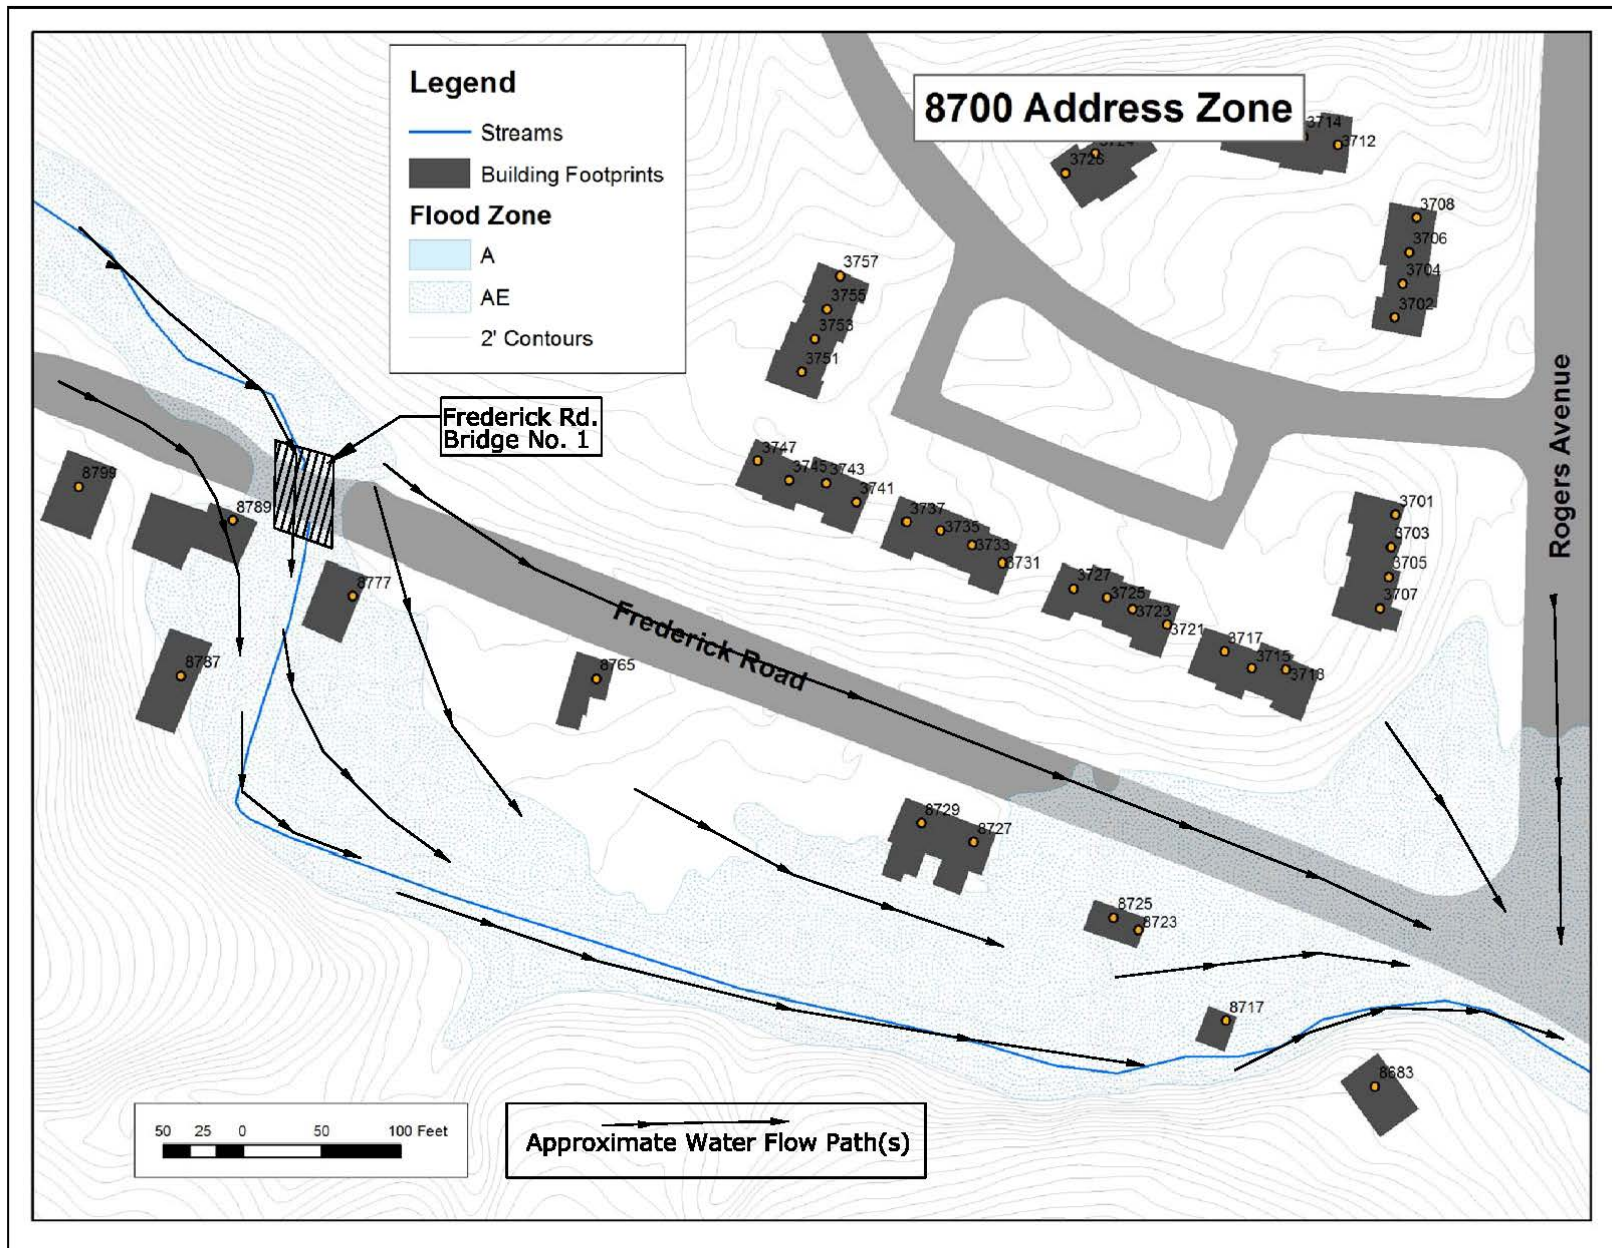
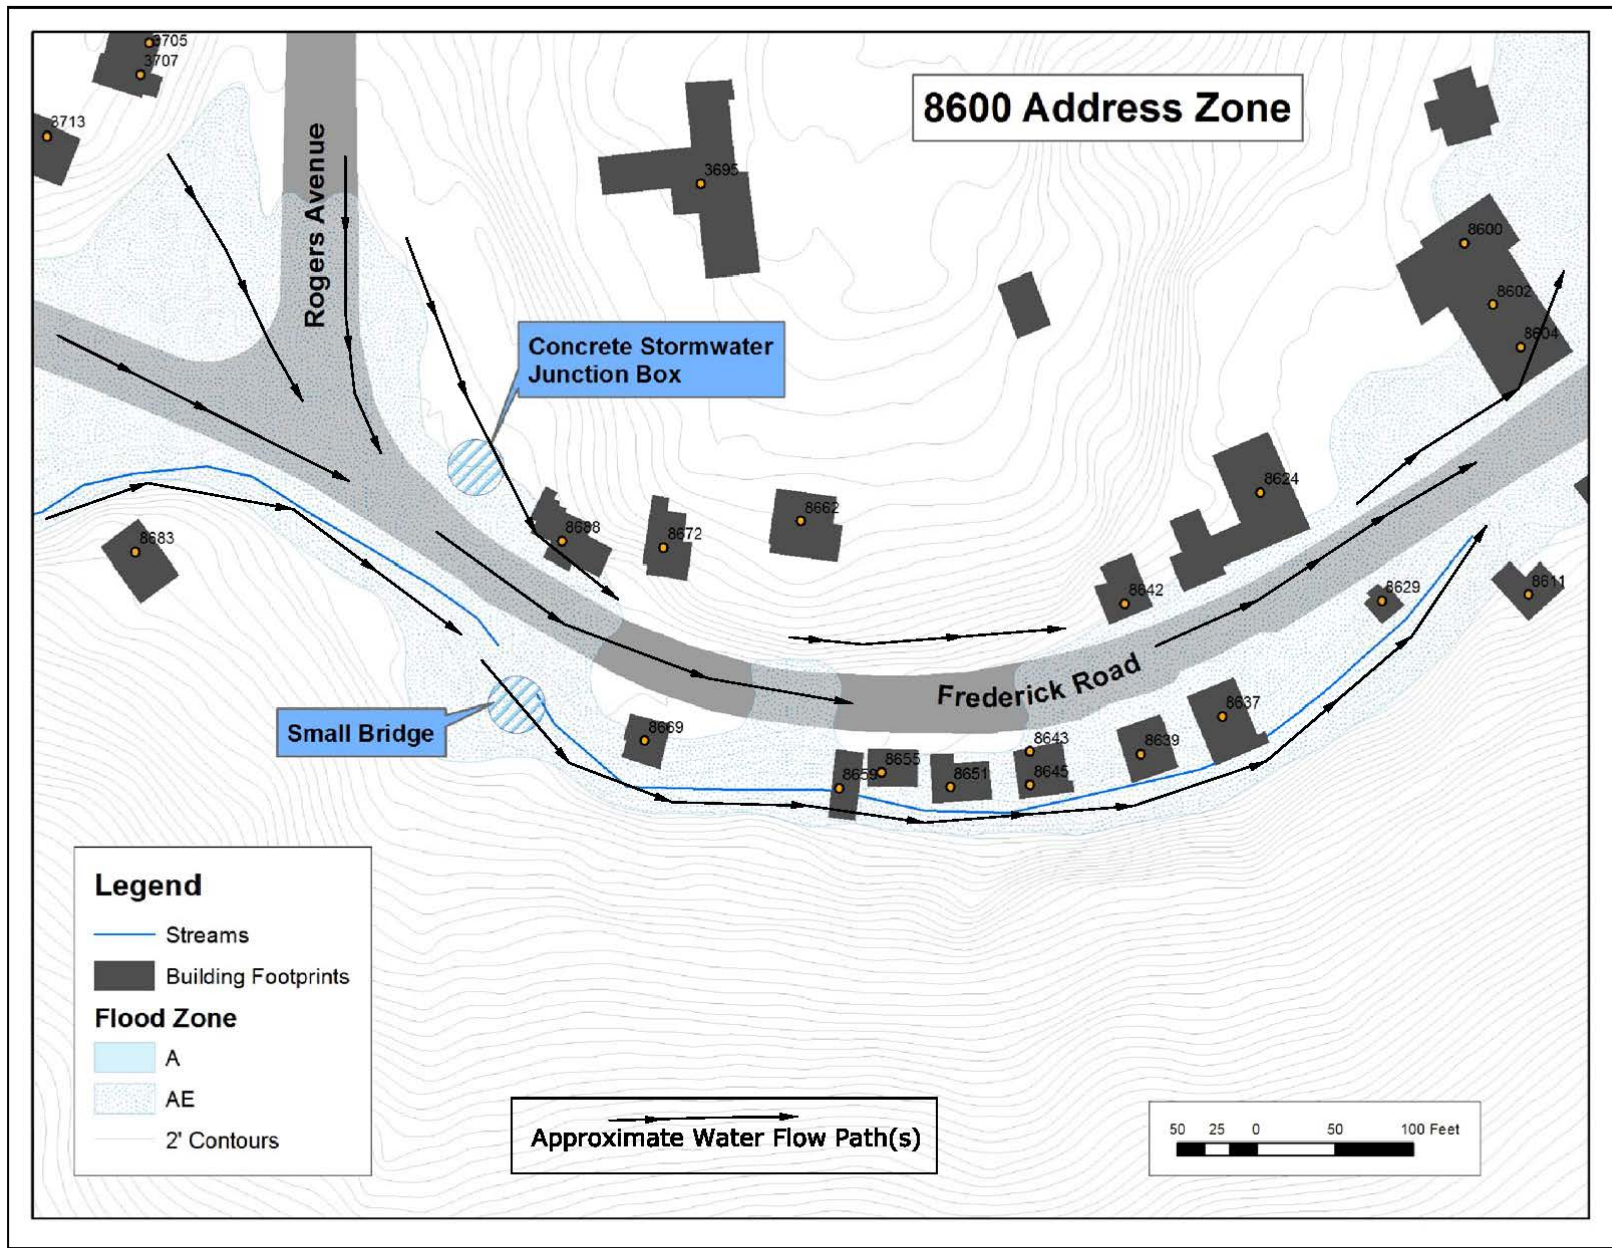
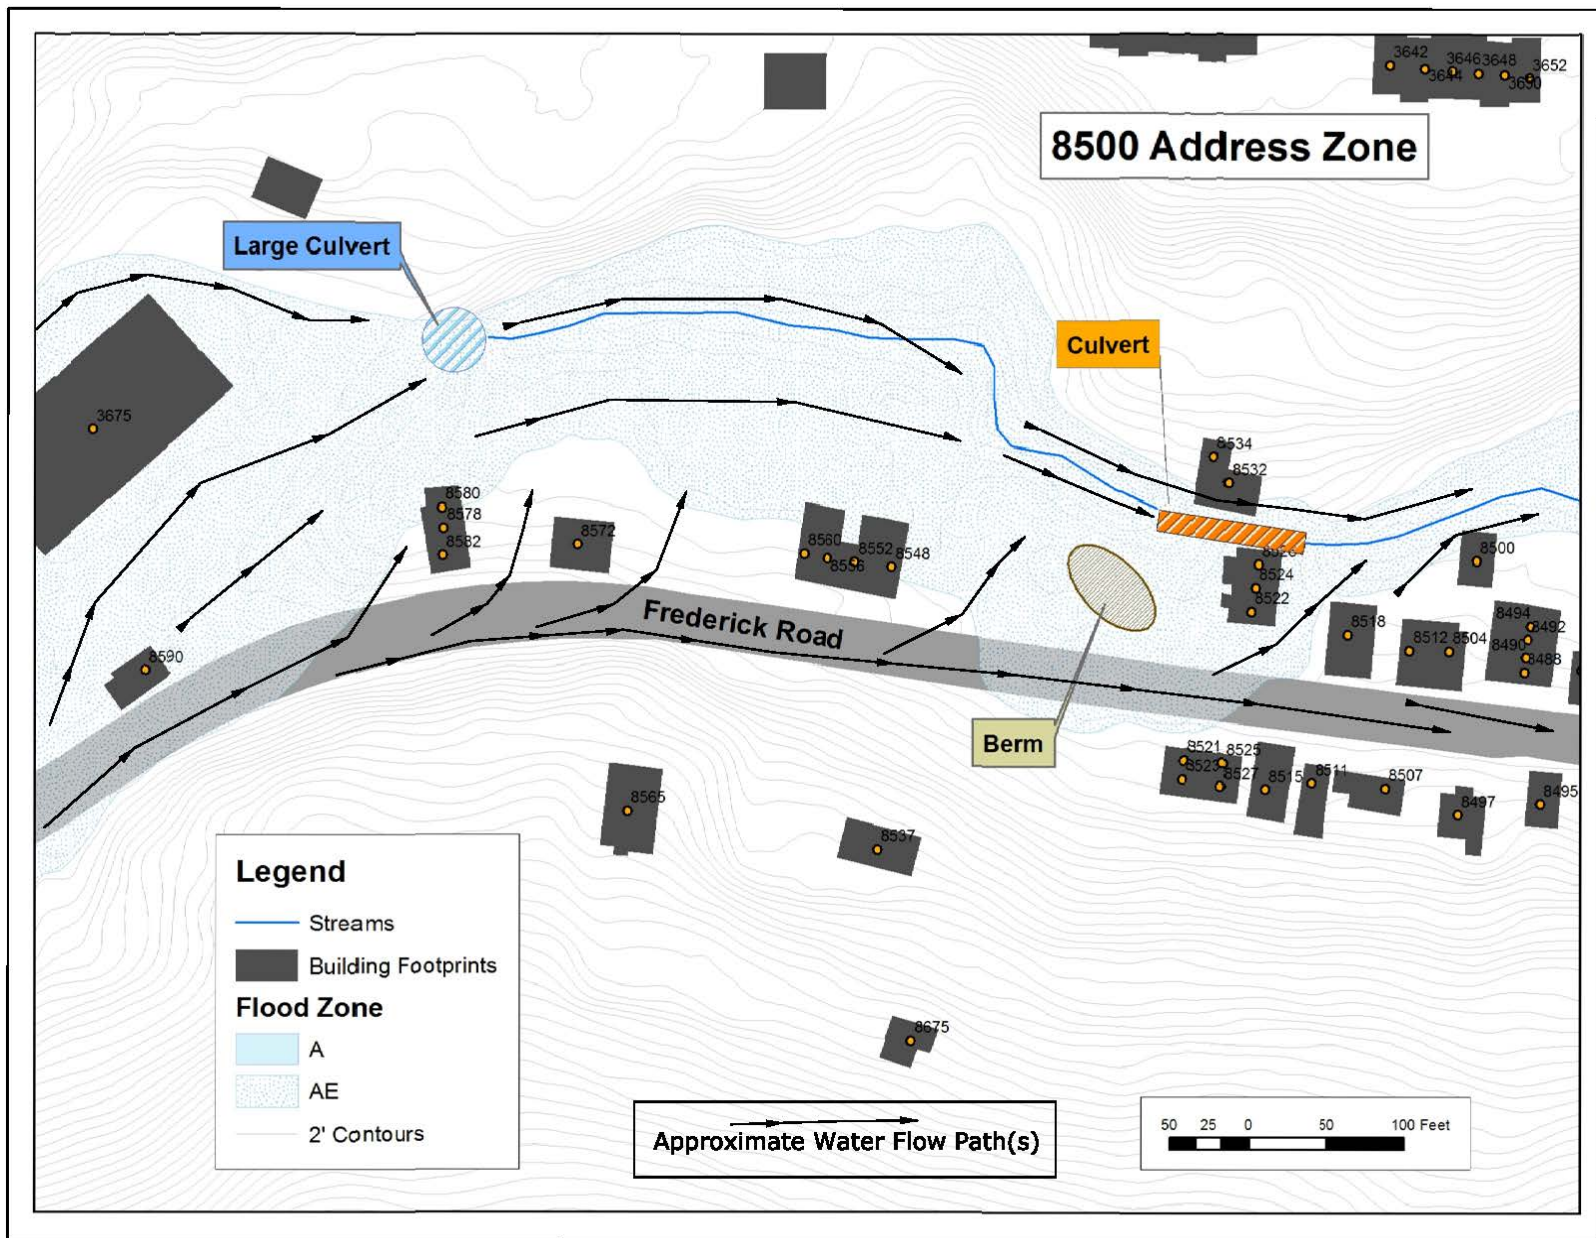
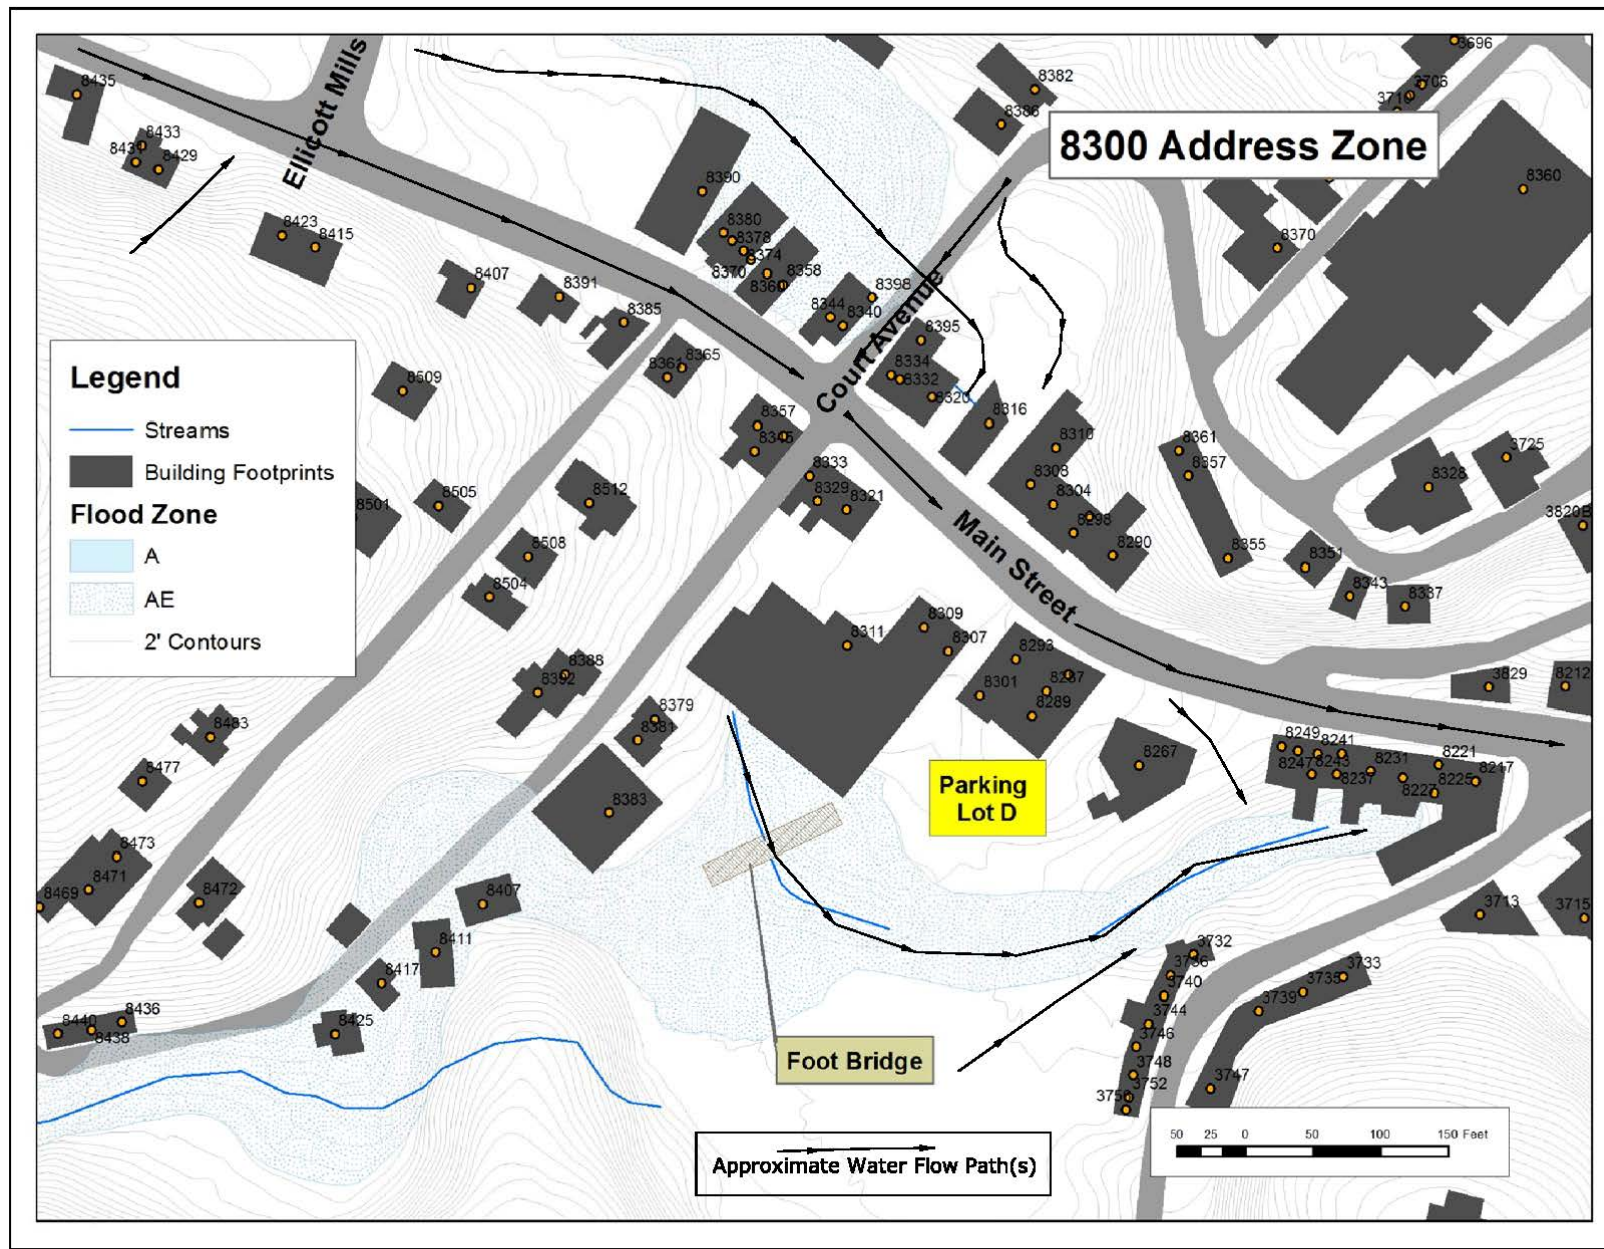
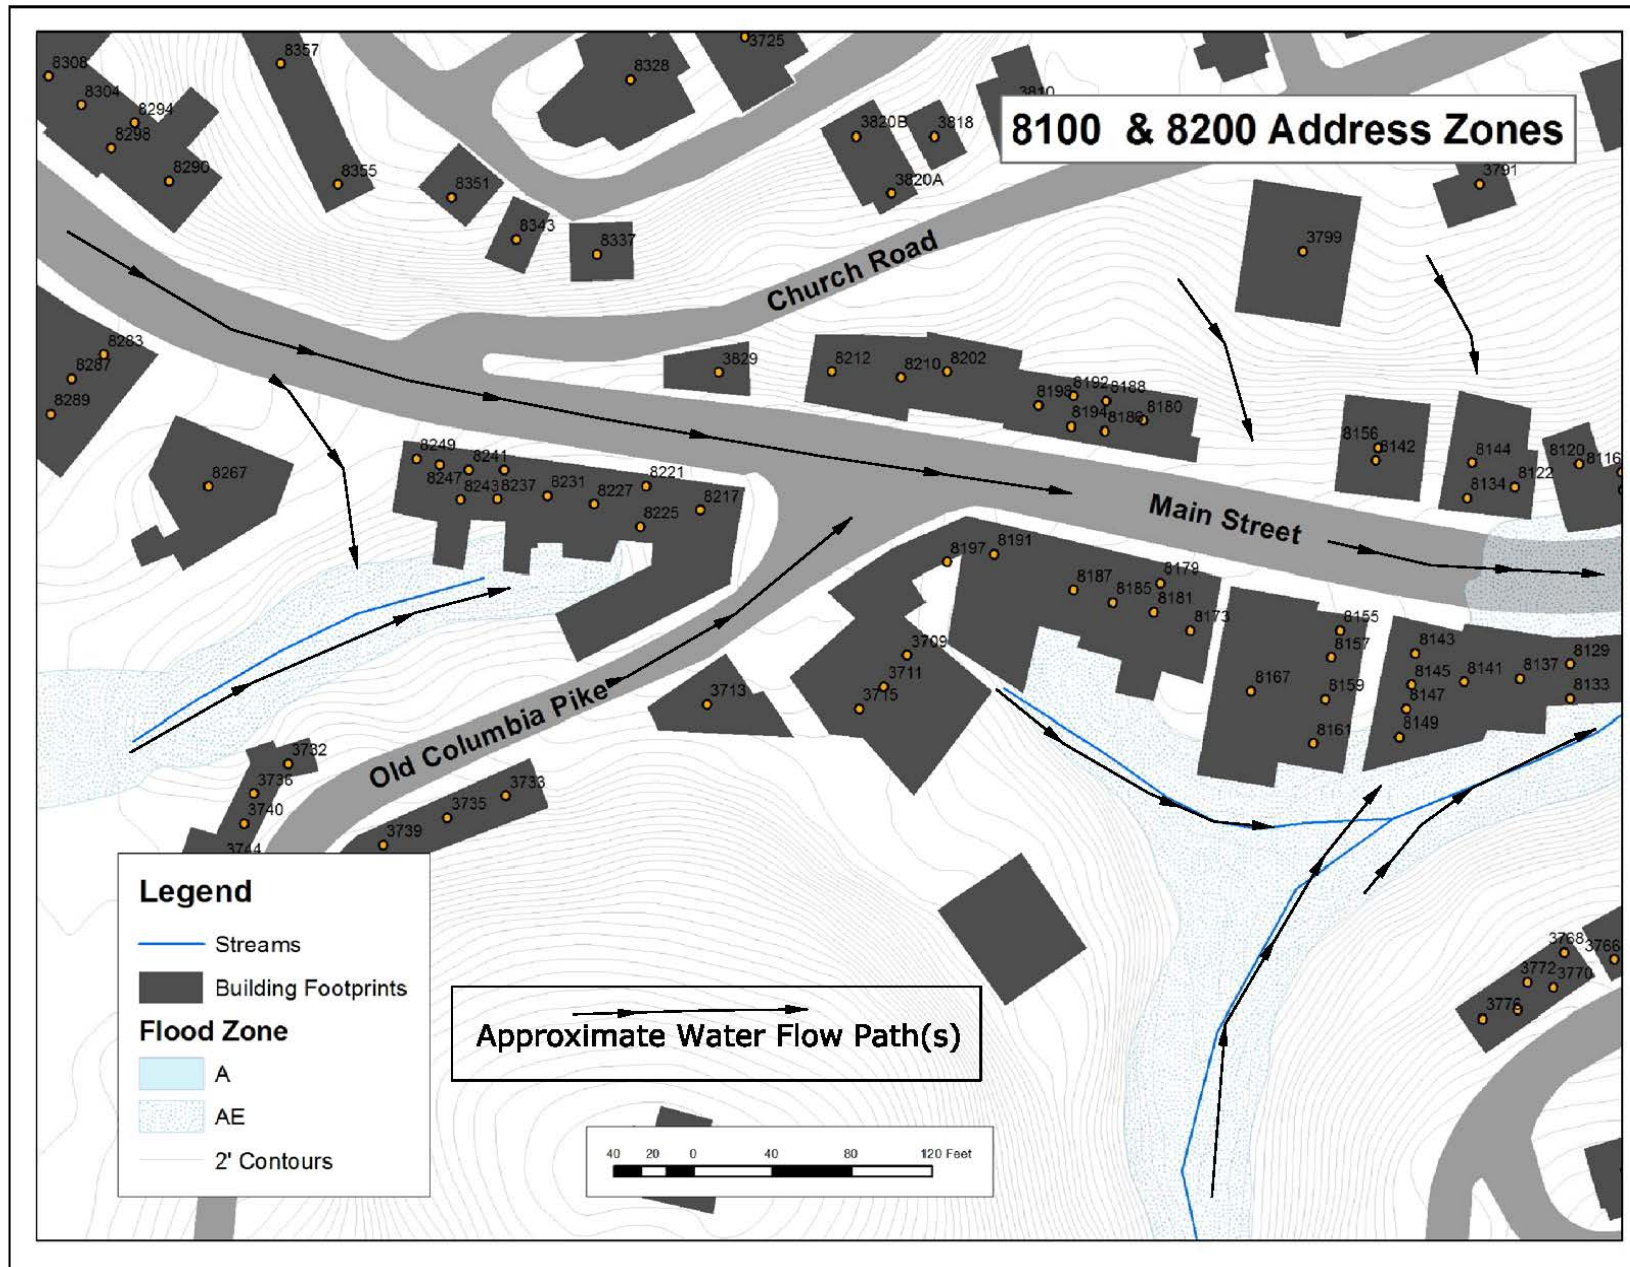
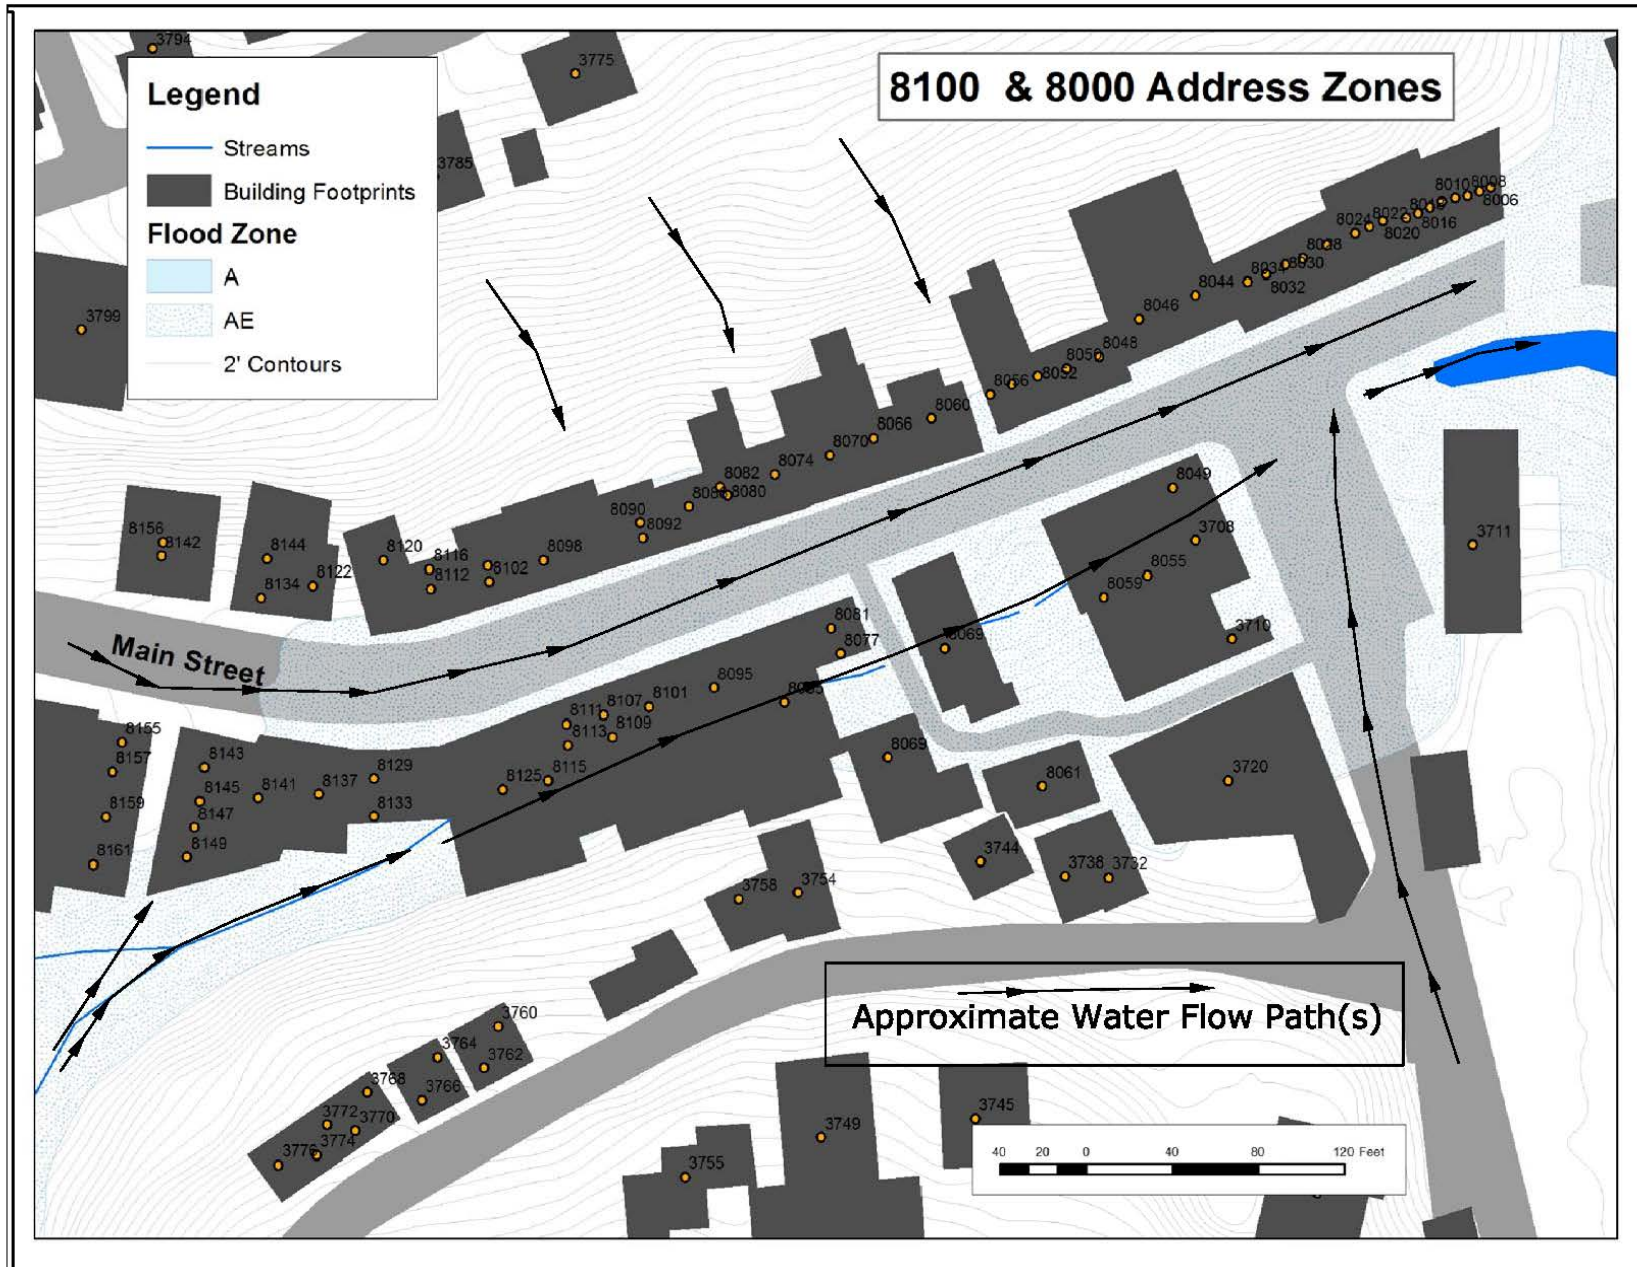
Information extracted from the *Description of Property Damages* Interview Form, as well as interviewer notes acquired during property owner interviews are compiled in narrative format and mapped to illustrate the approximate flow of flood waters by address zones.
